# The Lanes, Bee Lane, Penwortham

Stage 1 Road Safety Audit

November 2021

Client: Vectos (North) Ltd

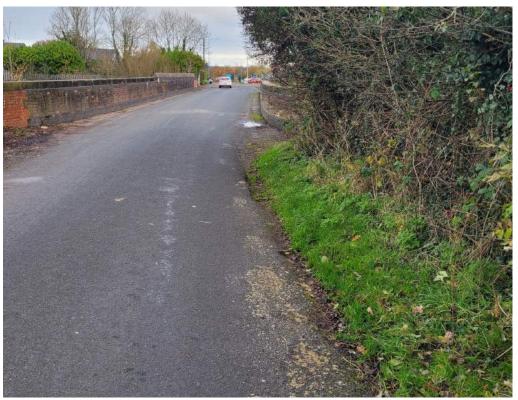
Problem 2		
Location	Eastern extent of footway on Bee Lane	
Summary	Carriageway alignment may lead to vehicles striking kerb

The alignment of the proposed southern kerb results in the end of the footway intruding into the carriageway where it may be struck by westbound vehicles, resulting in loss of control and increasing the risk of pedestrians being struck.

It is recommended that, in the absence of footway facilities on
Recommendation	the bridge, the footway is terminated further to the west to
	provide a smooth transition into the existing alignment.

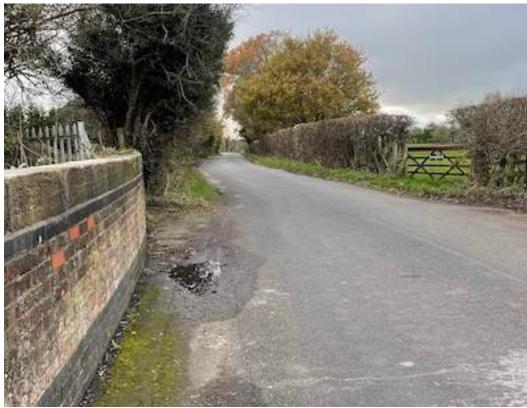
Problem 4		
Location	Gated field access	
Summary Extent of carriageway may lead to vehicles striking kerb

The provision of kerbing on the northern side of the carriageway extends up to and in front of the existing gate for the field. Vehicles turning right out of the field may collide with the new kerbing, resulting in loss of control.

It is recommended that the new kerbing is terminated further to the west of the gated access to ensure vehicles can turn out safely.

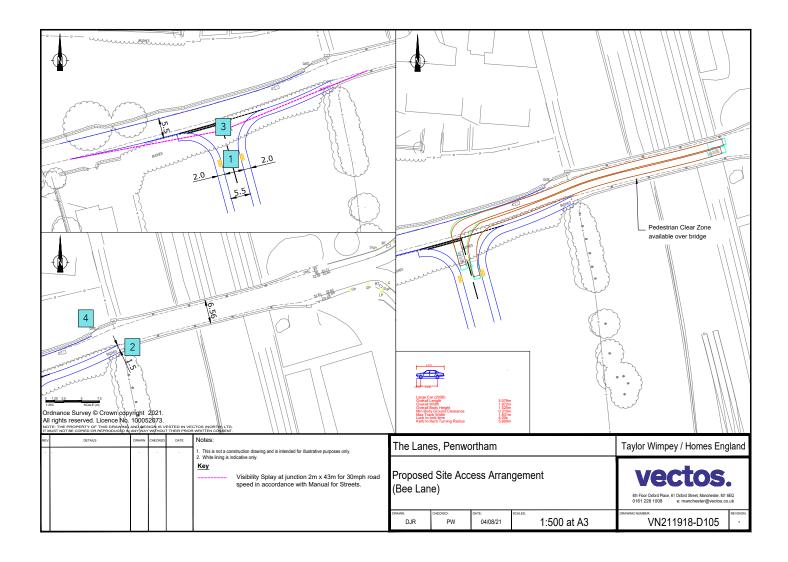
# Appendix C - Problem Location Plan

Problem 1		
Location	Site access	
Summary	Limited visibility for pedestrians crossing	
The pedestrian crossing facility on the site access road is set back into the development and visibility to turning traffic may be limited, resulting in pedestrians stepping into the path of traffic turning into the site.

Problem 3		
Location	Site access	
Summary	Refuse vehicles may strike vehicles approaching junction on the site access

The swept path of a refuse vehicle intrudes into the opposing carriageway and if insufficient intervisibility is not provided both approaching drivers may fail to avoid collision.

Recommendation It is recommended that an appropriate visibility envelope is provided to allow pedestrians to cross safely.

Recommendation	It is recommended that sufficient intervisibility is provided to		
Necommendation	allow approaching drivers to permit safe passage.
