Appendix 7.8
Bat Roost Survey Report

Document Title	The Lanes Bat Roost Report
Prepared for	Taylor Wimpey North West / Homes England
Prepared by	TEP - Warrington
Document Ref	6900.006

G6900.011 Ground Based and Aerial Tree Inspection Results

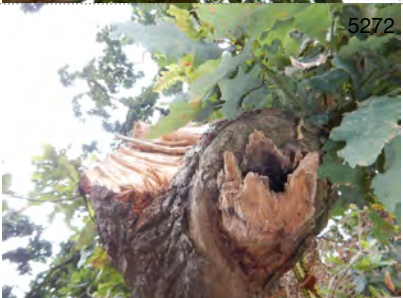
5272 Knot hole on end of fractured limb to the south side of tree. 5 cm entrance and 15cm horizontal travel. Cavity is dry	Low	Suitable as night roost	No
T91.3	PRF3	3	S

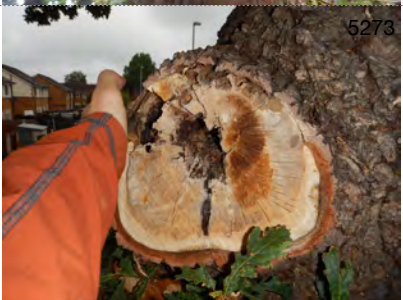
5273 Rot hole on trimmed limb. Not suitable for roosting bats	Negligible	Not suitable for bats	No

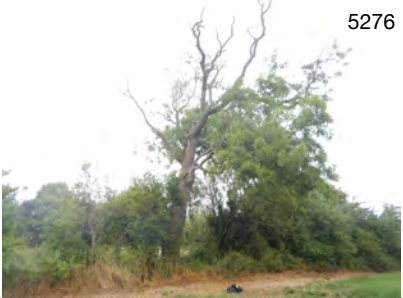
5276 Mature ash on field boundary, rot holes and knot holes in lead stems, checked and unsuitable below 7m, unsafe above. Precautionary moderate as features could not be checked.	Moderate	Precautionary moderate as some features could not be safely checked.	Yes
T90.1	PRF1	5	E

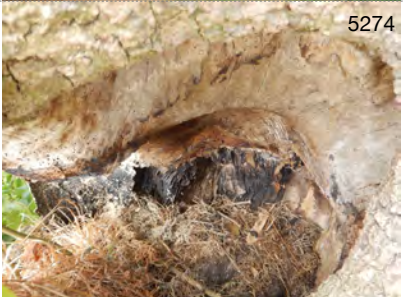
5274 Large tear out on main stem from east to south side. 70 x 40cm. Nesting / drey material. Negligible potential. Open to the elements.	Negligible	Unsuitable.	No
T90.2	PRF2	5	All.

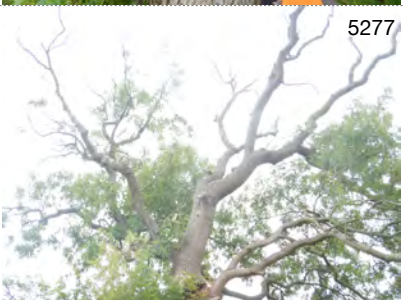
5277 Knot holes and woodpecker holes above 7m not checked as the tree is rotten and unsafe to climb above this point. Precautionary moderate.	Moderate		Yes

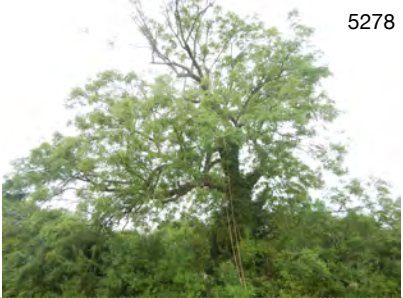
5278 Mature ash in field boundary hedgerow. Dead limbs, tear outs, rot holes, and woodpecker holes in the crown.	Moderate		Yes
T89.1	PRF1	8.1	N

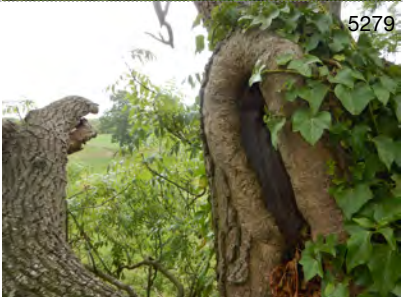
5279 Tear out in the vertical limb on the north side of the tree open to the elements. 45cm x10cm entrance into cavity 25cm wide x 40cm wide. Nesting material can be seen inside.	Negligible	Not suitable for bats	No
T89.2	PRF2	7.5	E

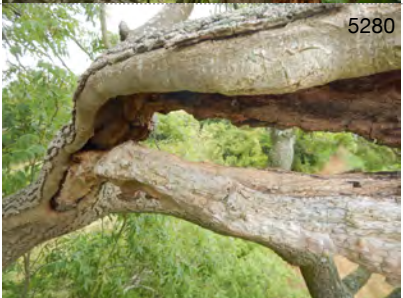
5280 Split in limb that travels the full length 1.5 m of dead/decaying limb located on the east side of the tree. Small cavity at the end of the limb < 10cm	Negligible	Not suitable for bats	No
T89.3	PRF3	7.5	Central

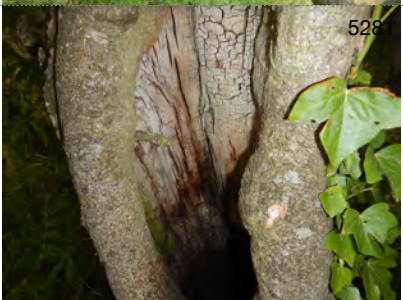
5281 Snapped off branch with a upward facing cavity 15cm diameter with 30cm downward travel.	Negligible	Not suitable for bats	No

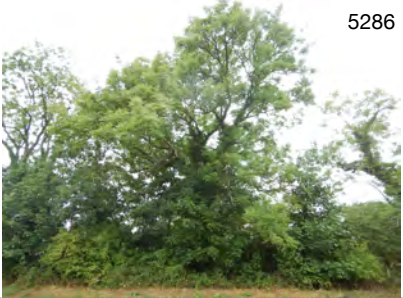
5286 Mature ash in hedgerow. Ivy from base, knot holes and deadwood in the crown. Nesting birds present unable to climb. Precautionary moderate, as knot holes look suitable through binoculars and torch.	Moderate	Unable to climb due to nesting birds.	Yes
T88.1	PRF1	4	NE

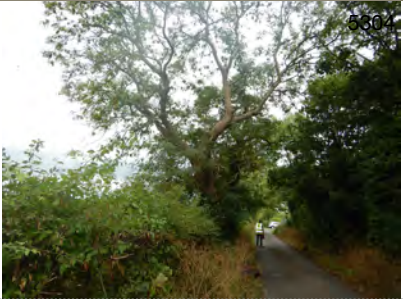
5304 Ash tree on Bee Lane, with rot hole in pruned limb at 4m on west side, possibly leading through to rot hole on east side of main stem at the same height. Not climbed as wood pigeons are nesting in the hole.	Moderate	Not climbed nesting wood pigeons.	Yes
T83.1	PRF1		4

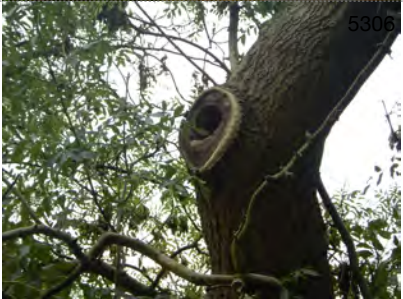
5306 Hole with wood pigeons nest inside.	Moderate		Yes
T82	Ash	15	70

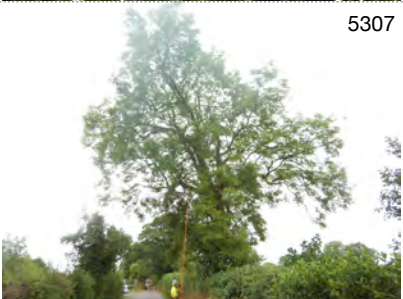
5307 Ash tree in hedgerow adjacent Bee Lane with missing limbs, and rot holes in the crown.	Moderate		Yes
T82.1	PRF1	6	E

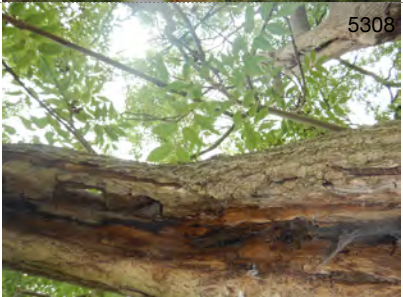
5308 Rot hole on underside of horizontal limb. 15cm x 2m. Open to the elements, unsuitable for roosting bats.	Negligible		No

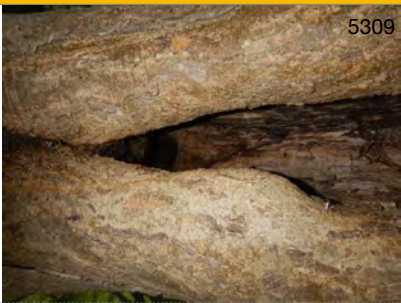
5309	Long tear out in vertical limb in centre of crown. 15cm x 3m. Callus rolls on sides, with a plate of heartwood, which is hollow behind. Entrance at base of callus roll. 5cm entrance into dry upward cavity for 1m. Old nesting materials present.	Moderate		Yes
T82.3	PRF3	7	E

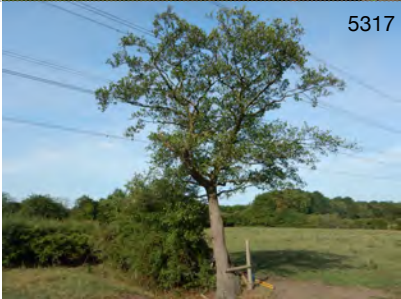
5317	Mature alder in field hedgerow. Rot holes in main stem and branches.	Moderate		Yes
T80.1	PRF1	2	E-W

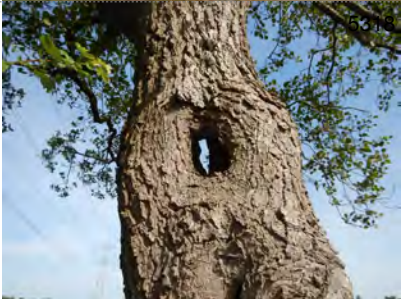
5316	Main stem cavity at 2m on east and west sides. 20cm diameter cavity with 1m upward and downward travel, cavity above at 3m let's water run through. Hollow main stem.	Moderate		Yes
T79	Alder	7	40

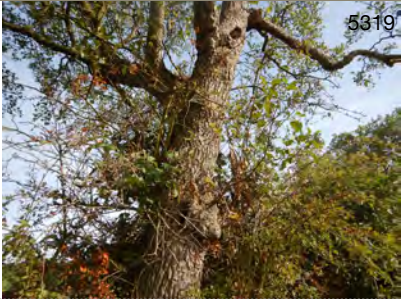
5319	Hollow main stem with cavities at 2m on south and 3.5m on west sides. Dry inside but water will run through in wet weather.	Moderate		Yes
T78	Alder	7	30

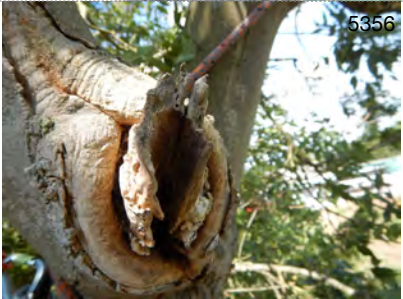
5356 Tear out with rot hole leading into vertical stem. 3cm diameter entrance With no suitable cavity.	Negligible		No
T58	Oak	14	70

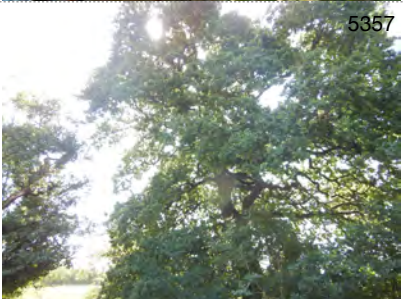
5357 Mature oak in corner of field. Multiple dead hung up limbs and rot holes.	Moderate		Yes
T58.1	PRF1	5	W

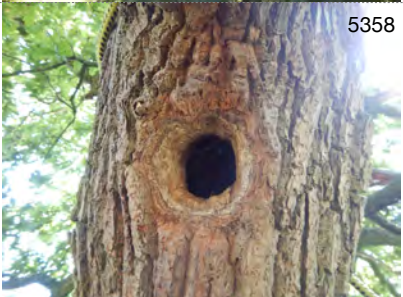
5358 Woodpecker hole on the underside of western limb 7 cm diameter entrance into 15cm diameter dry cavity with 20cm of upward and downwards travel bird nesting material present.	Moderate	Potential for small roost	Yes

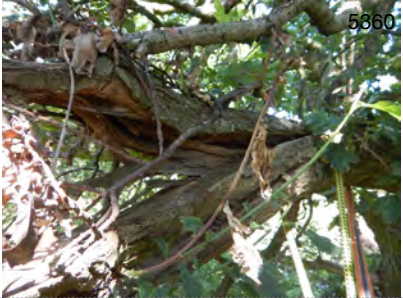
5360	Broken limb on south side with splits 1m long in the surface of the cambium, no suitable cavity, no potential for bats.	Negligible	Not suitable for bats	No
T57	Alder	6	30

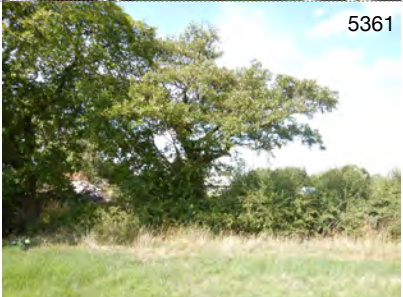
5361	Alder in field hedgerow. Light ivy cover from base, deadwood and rotting limbs in the crown.	Negligible	Labelled as sycamore on plan. No sycamore present. Ivy unsuitable for roosting bats.	No
T57.1	PRF1	5	E

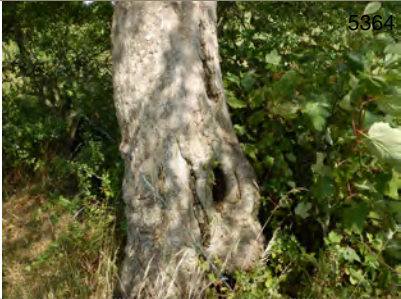
5364	Series of connected rot holes on south side of main stem. Wasps nest inside.	Low		No
T55	Oak	8	50

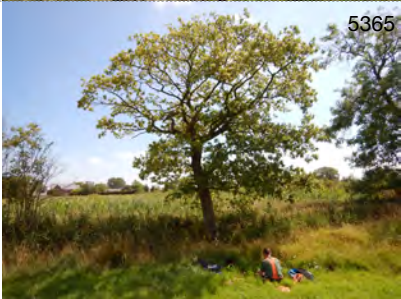
5365	Small oak in hedgerow with large tear out on the north side	Negligible		No
T55.1	PRF1	4	N

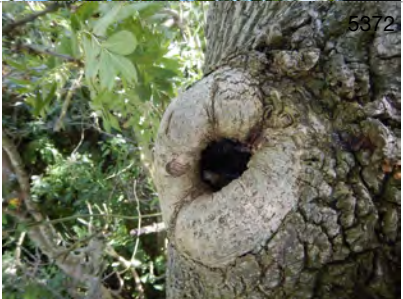
5372	Rot hole 10cm diameter entrance with no suitable cavity.	Negligible		No
T53	Ash	12	80

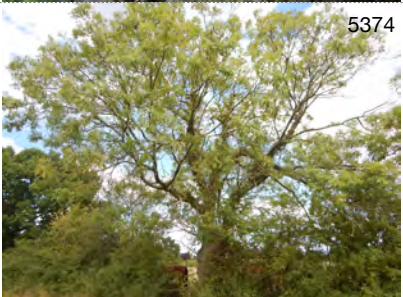
5374	Ash in field boundary hedgerow, light ivy cover from base into crown, large tear out and cavity in main stem.	Moderate		Yes

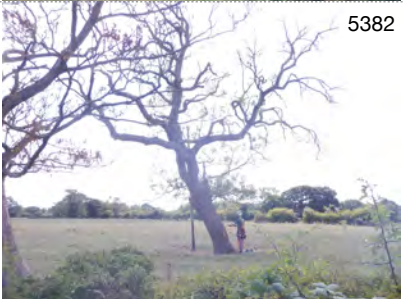
5382 Dying ash in field, dead limbs and rot holes in the crown. Climbed to 5m, not safe above.	Moderate	Could not be fully inspected as rotting and unsafe.	Yes
T49.1	PRF1	5	S

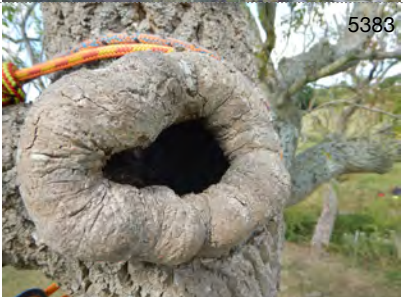
5383 Knot hole at 5m on south side with callus rolls. 15 x 10cm entrance into 15cm horizontal cavity. Exposed to the elements.	Negligible		No

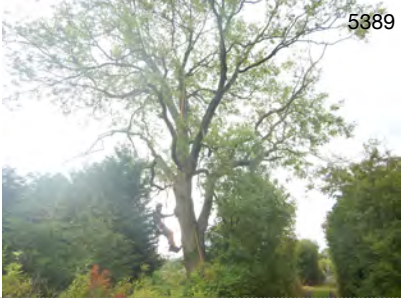
5389 Ash on garden boundary adjacent Moss Lane. Broken branches in the crown, knot holes on main stem and limbs. All features checked.	Low		Yes
T48.1	PRF1	4	SW

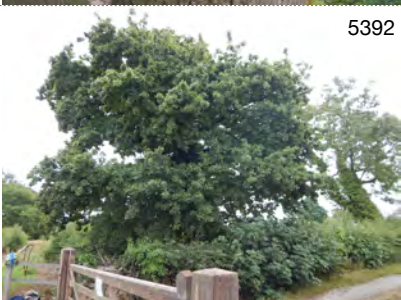
5392 Oak in corner of field hedgerow, adjacent dairy. Ivy clad from base into crown, minor wounds in bark and knot holes. Ivy not thick enough to form a roosting feature, no features found hidden by ivy.	Negligible	No suitable features present.	No

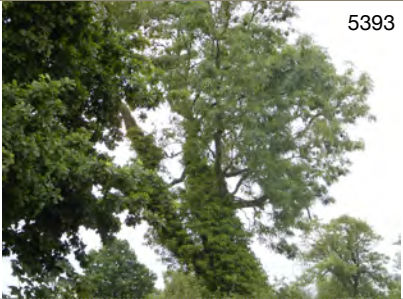
5393 Ash in field boundary, adjacent ivy cover from base into crown. Ivy not thick enough to form a roosting feature, no features found hidden by ivy.	Negligible	No suitable features present.	No
T45	Oak	10	80

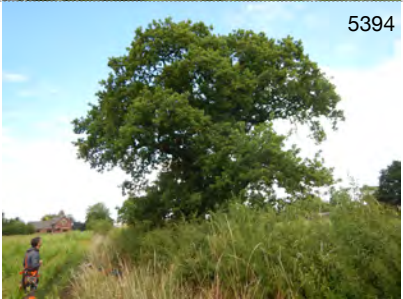
5394 Stunted Mature oak in field boundary hedgerow. Deadwood, knot holes and rot holes all visible. Partially ivy covered from base to 4m	Moderate		Yes
T45.1	PFR1	4	SW

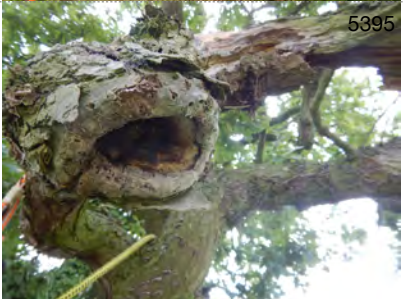
5395 End of limb tear out creates a 7CM entrance into a 3cm diameter cavity with 40cm of slight upwards travel. A feather was found at the entrance so birds have been using it. Potential for small bat summer roost.	Moderate	Potential for small summer roost.	Yes
T45.2	PFR2	4	E

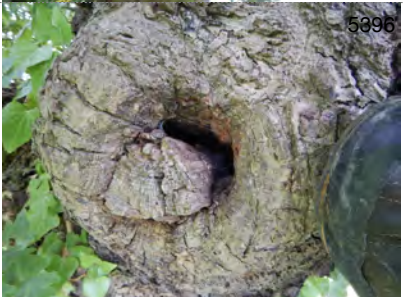
5396 Knot hole that still has the wood inside, small cavity created at the side of the wood, dry cavity that has a 10 x3cm entrance with 30cm diameter cavity and 30 cm of upward travel.	Moderate	Potential for small summer roost.	Yes

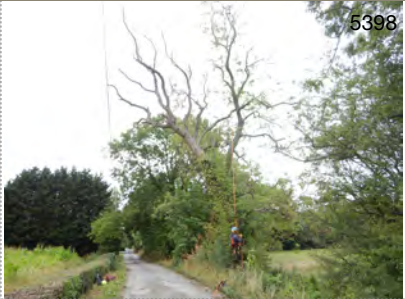
5398 Dying ash tree adjacent Moss Lane. East side of the crown is dead, overhangs the lane and telecoms wires, and is unsafe to climb.	Moderate	East side of crown unsafe to climb. And has knot holes which may lead into suitable cavities. Precautionary moderate as part of tree could not be safely climbed.	Yes
T44.1	PRF1	6	S

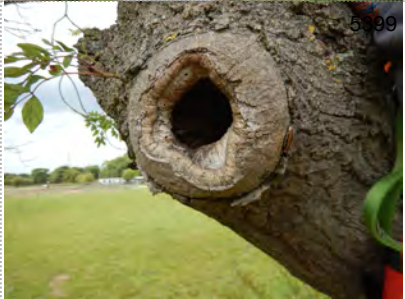
5399 Knot hole in vertical section of limb in the south of the canopy. 10cm diameter entrance into 15cm dry horizontal cavity. No upward or downward travel. Open to the elements.	Low	Suitable as night roost.	No
T44.2	PRF2	6.5	S

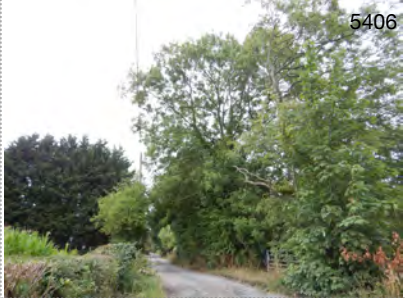
5406 Ash tree adjacent Moss Lane. Ivy cover from base to 12m. Climbed, rot holes, but no suitable cavities found. Ivy does not form a suitable roosting feature, or hide other cavities.	Negligible		No
T41	Alder	12	70

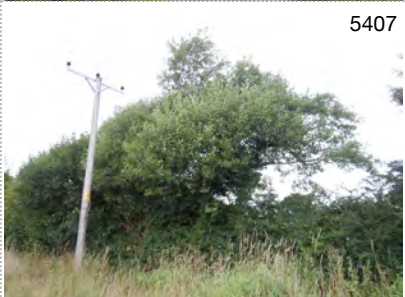
5407 Alder in field hedgerow adjacent ditch and high voltage power lines. Ivy cover from base and split with exposed heartwood.	Low	Unsafe to climb as high voltage cables pass within 50cm of crown.	No
T41.1	PRF1	2	W	iPhone	Split ion west side of main stem from base to 2m. Exposed heartwood leading into upwards traveling cavity, 15cm upward travel 5cm diameter. Cluttered entrance.	Low		No
T40	Alder	8	70

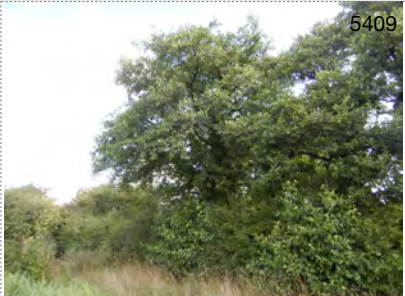
5409 Mature alder in boundary hedgerow, multi stem, ivy cladding from base to 7 meters, ivy checked but does not create any roosting feature and does not cover any cavities . knot hole on east side of tree.	Low	Ivy cladding is not suitable to support any bat roost. It is not concealing any cavities.	No

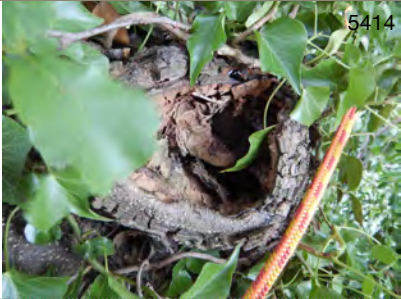
5414	Rot hole on snapped branch with 10cm diameter entrance into 10cm downward cavity. Open to the elements, wet inside.	Negligible		No
T37	Alder	8

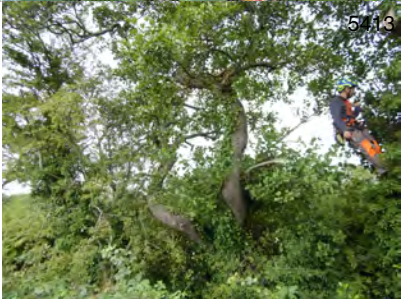
5413	Alder in field boundary hedgerow, broken branches in crown and knotholes in limbs.	Negligible		No
T37.1	PRF1	4	E

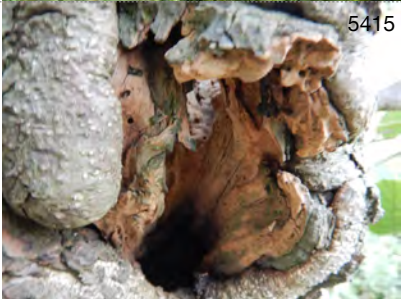
5415	Rot hole on underside of horizontal section of branch in centre of tree. 10cm x 5cm entrance into shallow wet cavity.	Negligible		No
T36	Oak	6	45

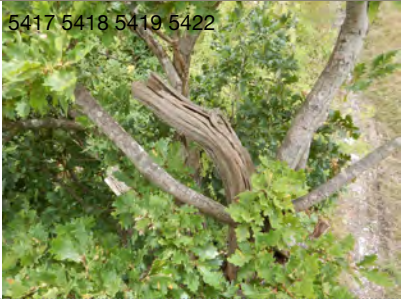
Series of dead and rotting branches throughout the tree. Missing and loose bark, knot holes and rot holes.	Low	Low potential for roosting bats.	No
T36.2	PRF2	4	W	5420

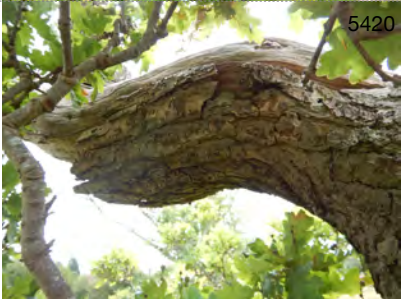
Loose bark on small snapped horizontal limb. Open to the elements on the west side but minor horizontal travel behind the bark.	Low		No
T36.3	PRF3	3	W	5421

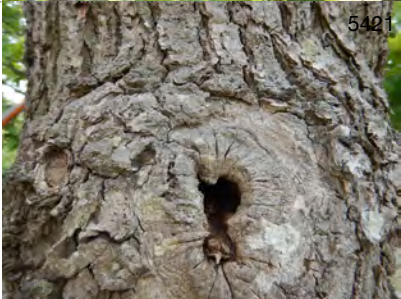
Knot hole 3cm diameter entrance into 3cm diameter cavity with 5cm of upwards travel.	Low		No
T35	Ash	12	60	5423

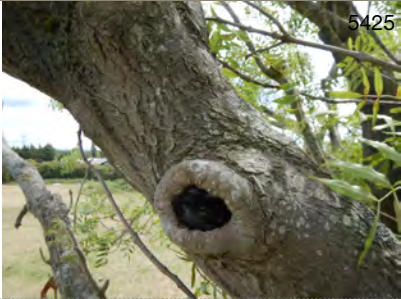
5425	Knot hole on north side of branch on east of the crown. 10cm diameter entrance into 5cm deep, wet cavity. Exposed and unsuitable for roosting.	Negligible		No
T35.2	PRF2	6	N

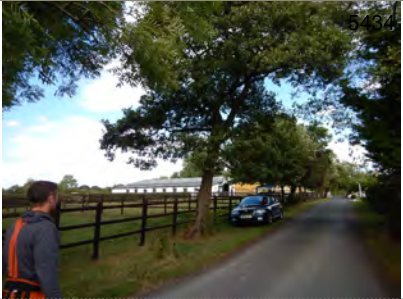
5434	Alder on corner of Lords Lane and stables. Snapped and rotting limbs in the crown, deep folds in bark on main stem, tear out and missing bark at base.	Low		No
T32.1	PRF1	Base	N

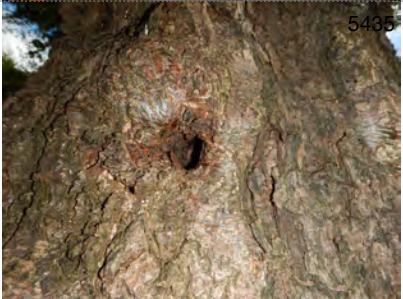
5435	Tear out at base with exposed heartwood from base to 1.5m, and 10cm of upward travel behind bark. Exposed cavity, unsuitable for roosting bats.	Negligible		No
T32.2	PRF2	1.8	N

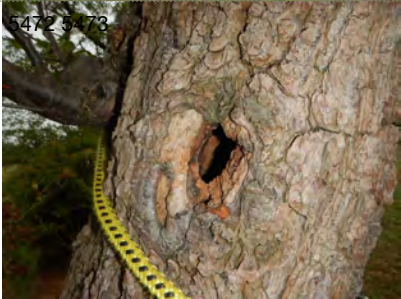
5472 5473 Rot hole 4cm entrance, travels 30cm up and down stem, 10cm diameter hole inside. Opens above through another rot hole. Rain will wash through.	Low		No
T28	Ash	12	70

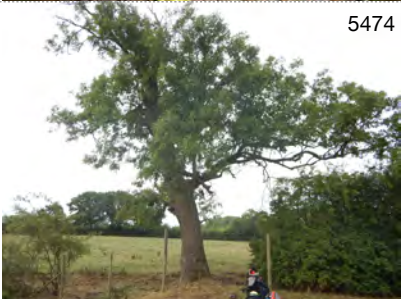
5474 Dying ash in hedgerow. Dead wood in crown. Rot and superficial scars in bark in all areas. Hole SE side from base to 1.8m, exposed heart wood. Woodpecker holes negligible. Precautionary moderate as tree cannot be safely climbed and there are features with potential in the crown.	Moderate	Unsafe to climb due to rot	Yes
T27	Alder	8	60

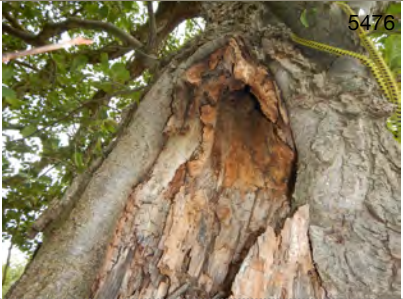
5476	Main stem cavity at 2.5m. Hollow upwards for at least 2m, dry and smooth, Enclosed from above. Potentially other chambers inside. Entrance 50 by 30 cm where bark is missing, down to 15cm diameter cavity.	High		Yes
T27.2	PRF2	5.5	E

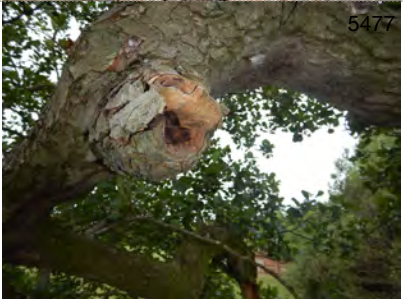
5477	Rot hole. 7cm diameter entrance. Travels 10m. Full of woodlice / insects.	Negligible		No
T26	Ash	12	65

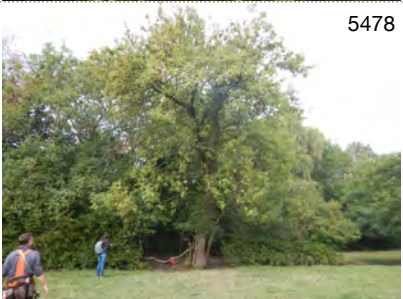
5478	Ash at end of hedgerow in corner of field. Light ivy cover. Wasp nest in one knot hole. Callous and knot holes within branches. Precautionary moderate.	Moderate	Unsafe to climb due to wasps nest in tree.	Yes
T26.1	PRF1	4	E

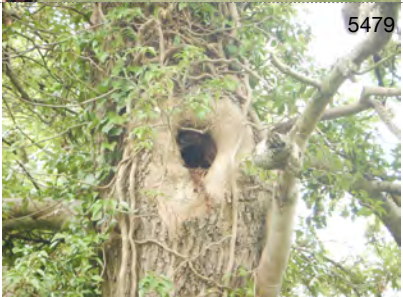
5479	Knot hole at 4m on E side. 15cm diameter entrance hole. Callous rolls into a main stem cavity, approx 10cm diameter, with upward travel.	Moderate		Yes

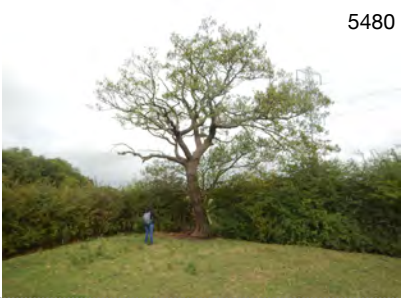
5480 Alder within hedgerow. Dead branches and knot holes in crown. knot hole at 3m on south side of main stem, has active wasps nest. Tree unsafe to climb.	High	Unsafe to climb.	Yes
T24	Alder	10	60

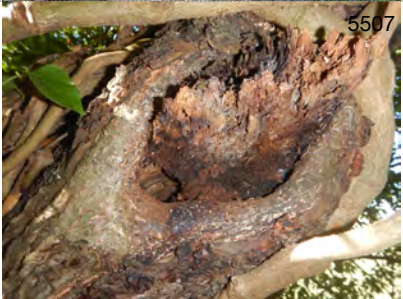
5507 Rot hole on south side of limb at 3m.	Negligible		No
T16	Ash	10	50

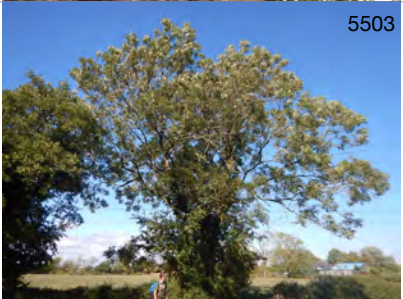
5503 Ash tree in field hedgerow rot holes on main stem and ivy clad from base to 9m.	Low		No
T16.1	PRF1	4	S

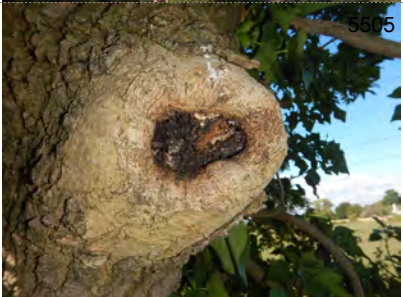
5505 Rot hole on south side of main stem. 7x5cm entrance with no travel no suitable cavity.	Negligible		No

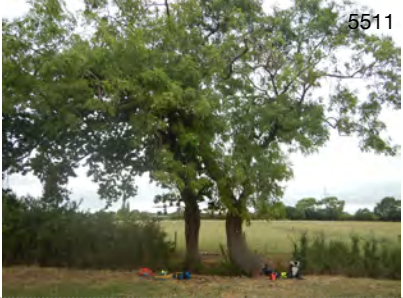
5511 Mature oak in field hedgerow, series of rot holes and deadwood, large split in main stem at 2 meters.	High	High potential for bats	Yes
T12.1	PRF1	5.3	E

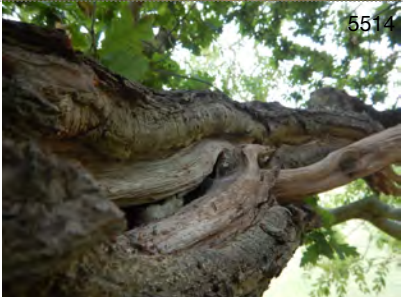
5514 Tear out on east side of the tree, 10 x 4cm entrance into tapering cavity with 7cm of horizontal travel.	Low	Low potential for night roost	No
T12.2	PRF2	2	E

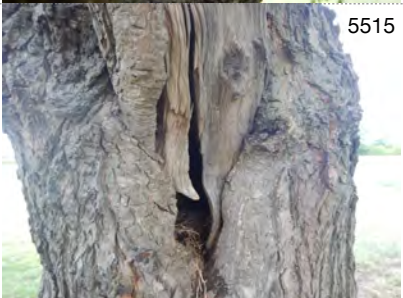
5515 Rot hole at 2 meters on the east side of the main stem, 30 x 10cm entrance leading into 30cm diameter dry tapering main stem cavity, with > 1m of upward travel.	High	High potential for summer roost	High
T11	Oak	12	60

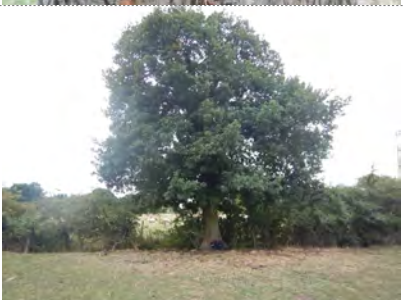
Mature oak in field hedgerow, light ivy cladding from base to 9m which does not form or conceal roosting features. Deadwood and knot holes in the crown.	Low		No

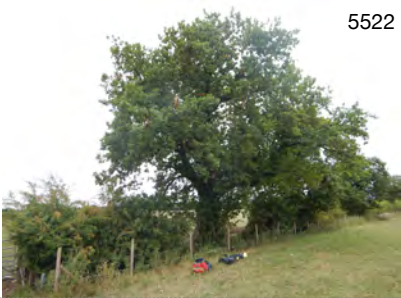
5522 Oak in field boundary hedgerow with deadwood and missing limbs in the crown, and tear out on west side of main stem.	Low		No
T10.1	PRF1	1.5

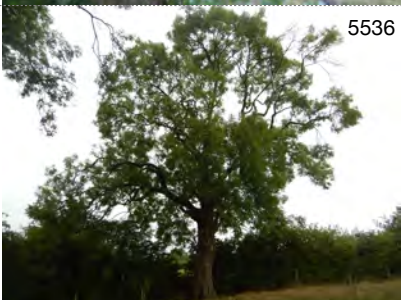
5536	Series of knot and rot holes, from 3 to 8 meters. Main stem cavity and dead wood in crown. Inspection abandoned due finding nesting swallows.	High	Main stem cavity currently has swallow's in it, but would make good large cavity for bats.	Yes

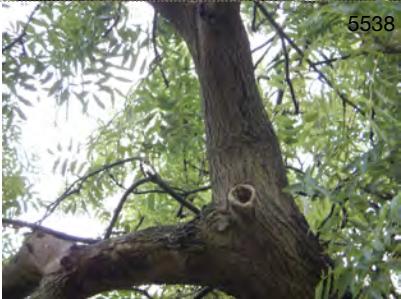
5538	Rot hole at end of limb, not inspected	Mod	Not inspected due to nesting birds	Yes
T6.3	PRF3	6	S
