Appendix 7.8
Bat Roost Survey Report

Document Title	The Lanes Bat Roost Report
Prepared for	Taylor Wimpey North West / Homes England
Prepared by	TEP - Warrington
Document Ref	6900.006

G6900.011 Ground Based and Aerial Tree Inspection Results

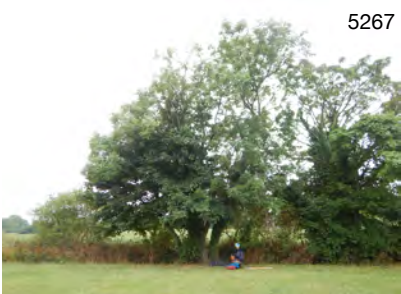
5267 Multi stemmed ash tree with partial ivy covering to lower half of main stems. Minor knot holes in stem and limbs.	Negligible	Unsuitable for roosting bats.	No
T92.1	PRF1	4	All around

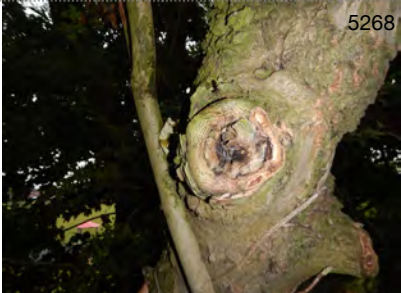
5268 Multiple knot holes with no suitable cavity from 4 to 6m.	Negligible	Unsuitable for Bats	No
T92.2	PRF2	Base	All around

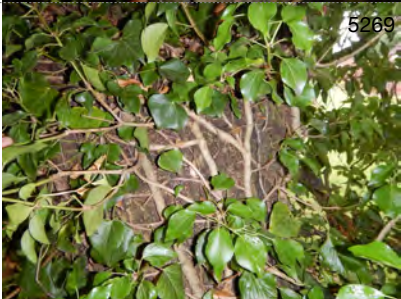
5269 Light ivy cover from base to 6 m. It does not cover any cavities and is not thick enough to form a roosting feature.	Negligible	Unsuitable for Bats	No

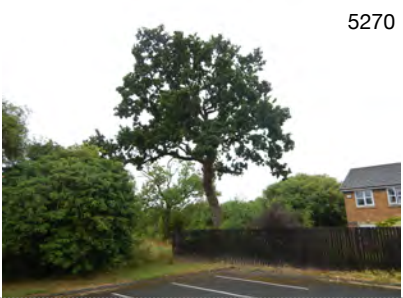
5270 Mature oak, partial dead ivy cover on main stem, tear out and knot holes located on south side of tree	Low		No
T91.1	PRF1	7.5	S

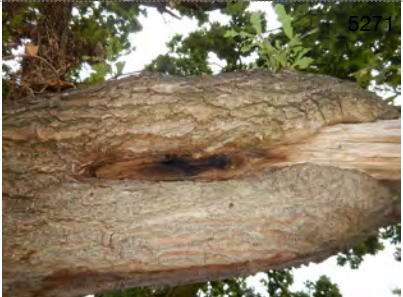
5271 40 x 5cm tear out on south side of tree. There is a minor cavity that is open to the elements with 5cm horizontal travel.	Low	Suitable as night roost	No
T91.2	PRF2	6	S

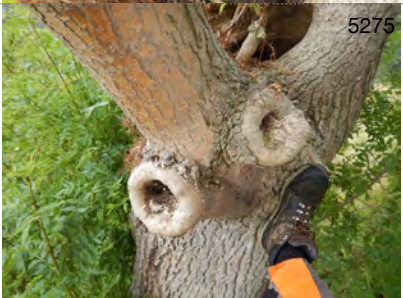
5275 Knot holes below 7m checked and have no suitable features.	Negligible		No
T90.3	PRF3	>7	All

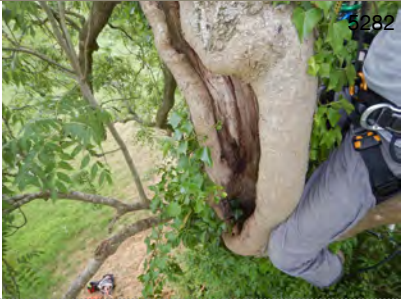
5282	Vertical tear out on limb that sits on north side of the tree. 2cm wide and vertical travel of 1mt open to the elements	Negligible	Not suitable for bats	No
T89.5	PRF5	5	E

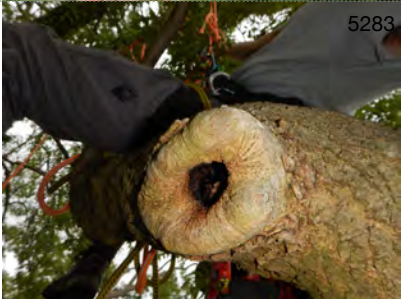
5283	Knot hole on underside end of limb. Entrance is 15cm wide with 15cm of horizontal travel wide cavity.	Low	Potential night roost. In a couple of years could work well as roost	No
T89.6	PRF6	5	E

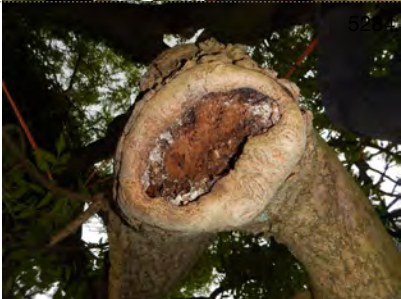
5284	Small tear out on end of limb on the east side of tree. 8cm by 15 cm entrance with minor cavity with no travel	Negligible	Not suitable for bats	No
T89.7	PRF7	5	E

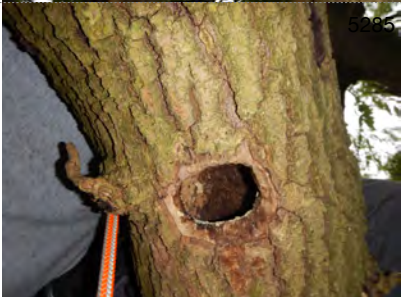
5285	Woodpecker hole on dead decaying limb to the east side of the tree. Dry cavity with entrance of 5cm horizontal travel of 25cm	Moderate	Potential for small roost	Yes

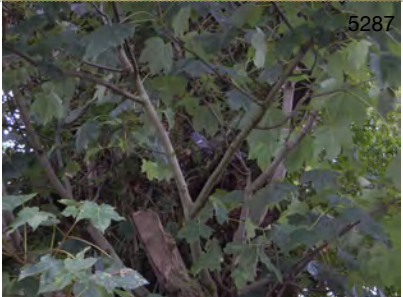
5287 Nesting wood pigeon present.	Moderate	Precautionary moderate due to nesting birds.	Yes
T87	Ash	15	60

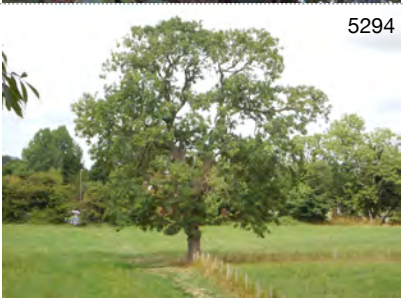
5294 Ash tree in field on corner of fence line. Deadwood fungus, and knot holes on main stem and in crown.	Moderate		Yes
T87.1	PRF1	3	N

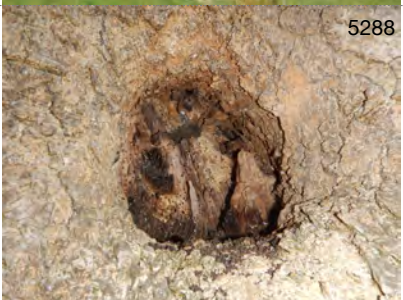
5288 Knot hole on main stem 10cm diameter entrance into 5cm diameter cavity with 10cm upward travel. Wet, slug filled.	Negligible	Unlikely to be used as slug filled.	No

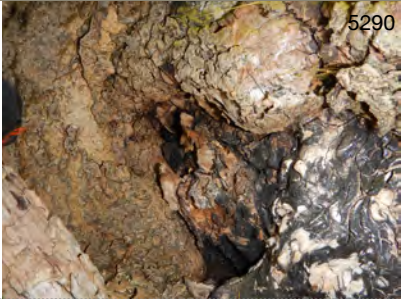
5290	Tear out at 4m on main stem beneath huge bracket fungus. No suitable cavity.	Negligible		No
T87.3	PRF3	9	S

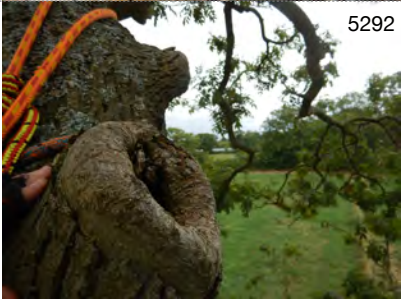
5292	Two knot holes on vertical limb in the south of the crown. <7cm diameter entrance with no suitable cavities.	Negligible		No
T87.4	PRF4	7	S

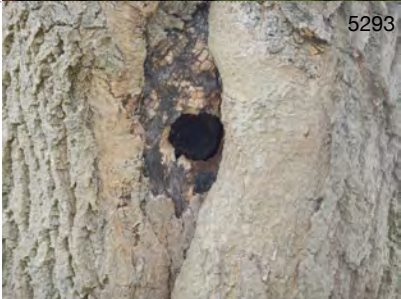
5293	Tear out on underside of main stem from 5 - 7m. Bark is healing, with closed callus rolls, and a woodpecker hole at the top of the feature. 5cm diameter entrance into dry downward cavity with 10cm diameter for 20cm.	Moderate		Yes
T86	Ash	14	70

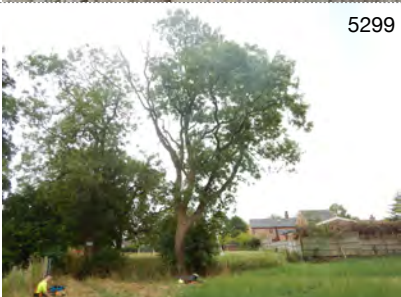
5299	Mature ash tree showing signs of ash dieback chalara large amount of cankers creating some low suitability features.	Low		No

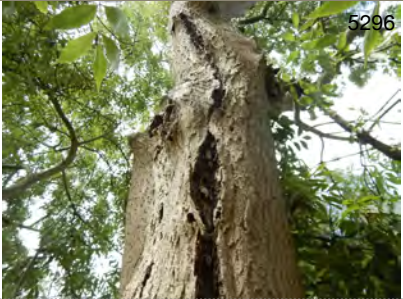
5296	Bark on all sides of the tree, at all heights, has a series of cankers and scars which offer low potential roosting features for single bats.	Low		No
T86.2	PRF2	8m	W

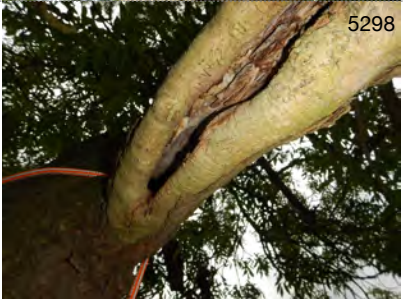
5298	Tear out on limb to the west side of the tree. 30 x 5cm entrance into 5cm diameter horizontal cavity dry at entrance wet at back of cavity.	Low		No
T85	Ash	15	40

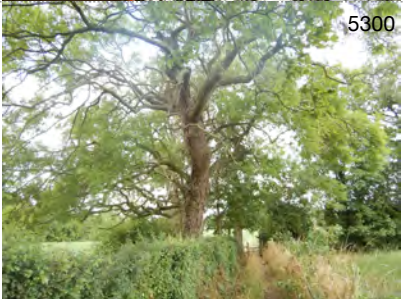
5300	Ash tree on garden boundary adjacent public footpath. Knotholes in crown on all aspects. Not climbed as on private land.	Moderate		Yes
T84	Ash	15	60

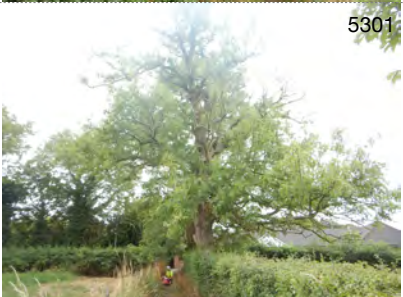
5301	Ash tree on garden boundary adjacent public footpath. Knotholes in crown on all aspects. Not climbed as on private land.	Moderate		Yes

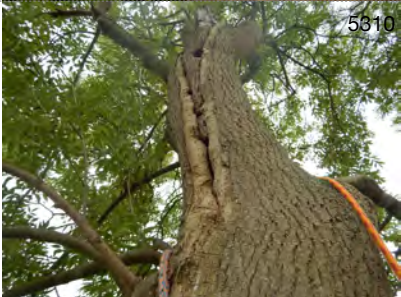
5310	Woodpecker hole on vertical limb facing north in the east of the crown. 7cm diameter entrance, into smooth cavity partially wet, with 10cm downward travel. Knot hole on same limb has no cavity.	Low		No
T81	Ash	13	1

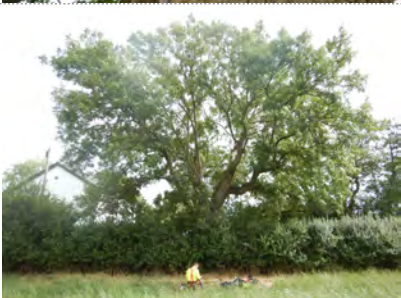
Mature ash tree in hedgerow on bee lane. Tear out and knot holes visible. At the base of the tree it has been hollowed out by lightning strike. Hollow stem has covered cavity for 1m into lead stem on west side of tree which has day roosting potential.	Moderate		Yes

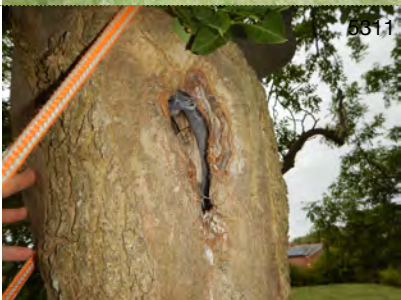
5311	5 x15cm tear out goes in 10cm tapering cavity with 5cm of upwards and downward travel dry but full of cobwebs	Low	Suitable for single bats.	No

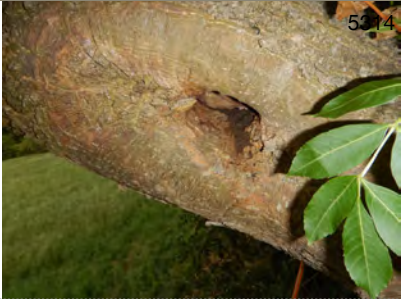
5314	West facing knot hole at 4m, 10 cm entrance into 5cm open cavity no upward or downward travel. Potential as night roost for single bats.	Low		No
T80	Alder	7	40

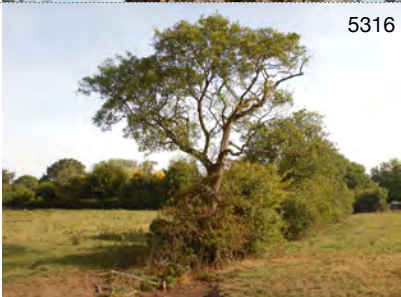
5316	Mature alder in field hedgerow. Rot holes in main stem and branches	Moderate		Yes

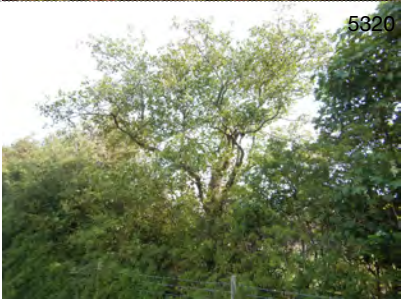
5320	Alder in field hedgerow boundary. Not climbed as on private land.	Moderate		Yes
T78.1	PRF1	3	S

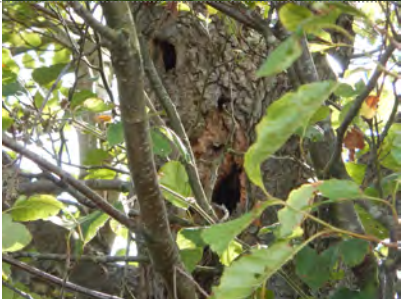
5021	Hollow main stem, with woodpecker holes at 2m and hole on top of main stem, likely that water runs through.	Moderate	Cluttered.	Yes
T77	Sycamore	13	40

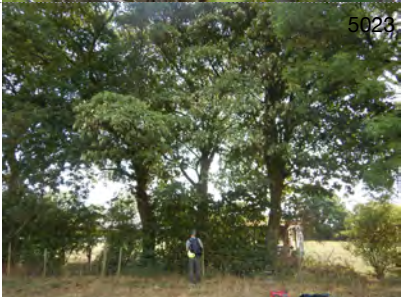
5023	Sycamore in field hedgerow boundary. Not climbed as on private land.	Moderate		Yes

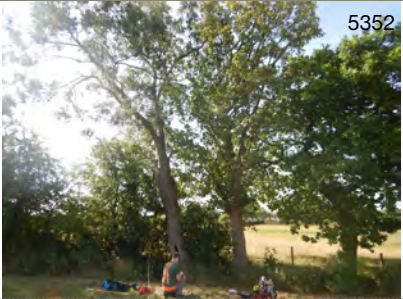
5352 Sycamore in field hedgerow. Deadwood in crown, knot holes on main stem. All knot holes on main stem checked.	Low		No
T60.1	PRF1	6.5	N

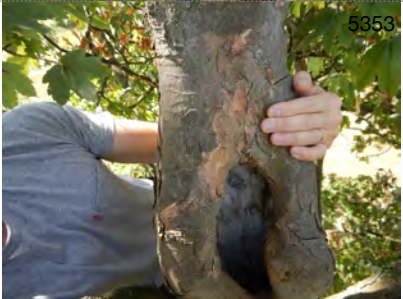
5353 Tear out at the top of the main limb. 10 x 20 cm entrance with 15cm downward travel the cavity is fully exposed to the elements.	Negligible	Not suitable for bats	No
T60.2	PRF2	6	S

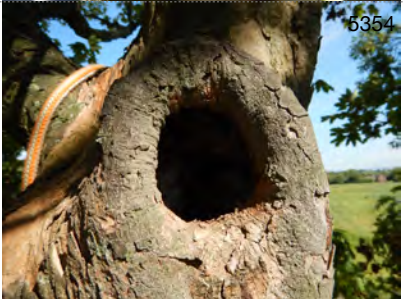
5354 Knot hole 7cm diameter 10cm of upward travel with 5cm diameter tapering cavity. Bird droppings are also visible. Cavity is open to the elements.	Low	Low potential for a night roost	No
T59	Ash	10	50

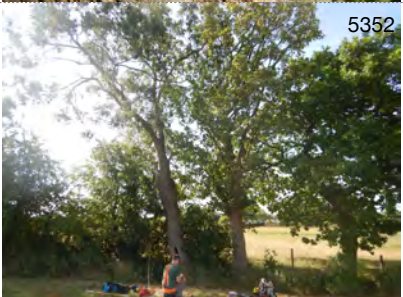
5352 Ash in field hedgerow, dead branches in crown, knot holes and tear outs in main stem. Cavity at base, stem hollow from base to 3m.	High		Yes

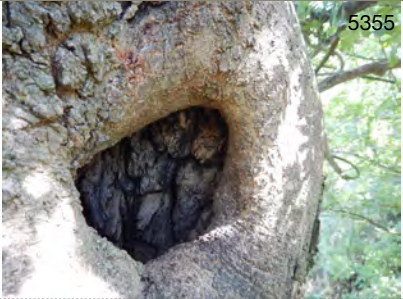
5355 Cavities at base, 2m and 3m lead into a main stem cavity. 30cm diameter, dry & smooth inside.	High	Potential for high number of bats, over a prolonged period.	Yes
T59.2	PRF2	6.5	E

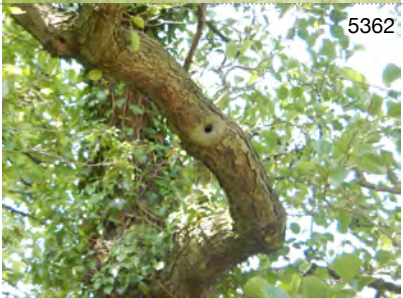
5362	Small knothole in limb, 2cm diameter entrance with no suitable cavity.	Negligible		No
T56	Sycamore	10	60

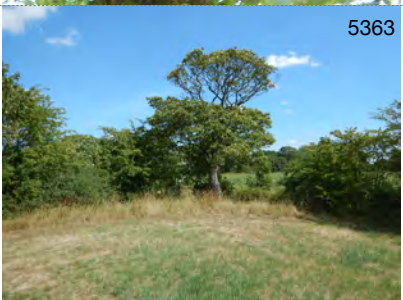
5363	Sycamore in corner of field hedgerow. Double crowned. Knot holes and deadwood in main stem and limbs. Wasps nest in main stem cavity at base.	Low		No

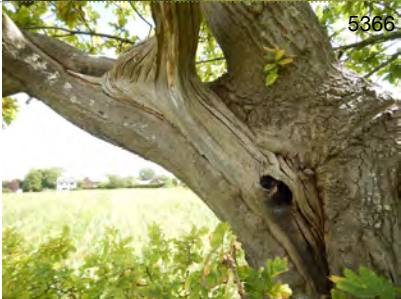
5366	Tear out on north side of tree 7cm entrance into 7cm shallow cavity with no horizontal or vertical travel.	Negligible		No
T54	Ash	15	70

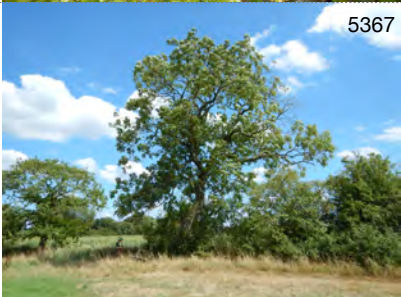
5367	Ash tree in field hedgerow boundary. Knot holes on main stem and limbs, deadwood in the crown.	Moderate		Yes

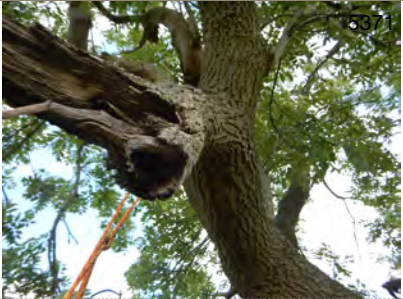
5371	Hole in end of snapped, downward facing limb, 5cm diameter entrance with minor 5cm cavity.	Negligible		No
T54.2	PRF2	8	S

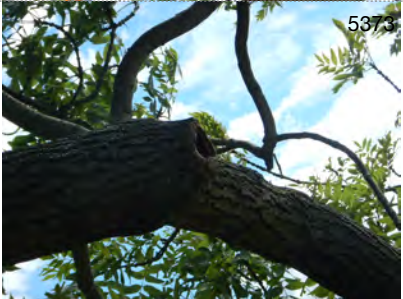
5373	Woodpecker hole in horizontal limb in south of canopy, west facing entrance, 7cm diameter into 5cm diameter dry horizontal cavity with 30cm horizontal travel.	Moderate		Yes
T54.3	PRF3	2	N

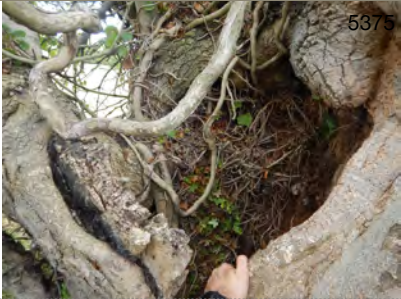
5375 Tear out with large open cavity in main stem, 50cm diameter open cavity, with 2m downward travel in main stem. More than 1m of upward travel in vertical limbs, into dry cavities, 20cm diameter.	Moderate	Potential for summer or winter roost. Little clear drop distance when exiting or entering, otherwise would have high potential.	Yes
T52	Ash	10	60

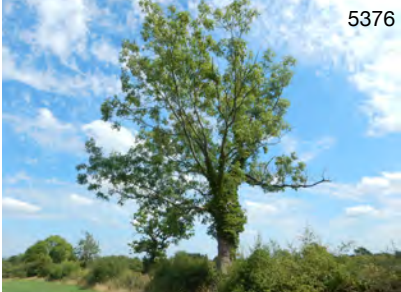
5376 Ash in field boundary hedgerow, adjacent track. Dead and rotting limbs in the crown, ivy cover from the base.	Moderate	Ivy cover and rot holes are unsuitable for roosting bats.	Yes
T52.1	PRF1	Base	N

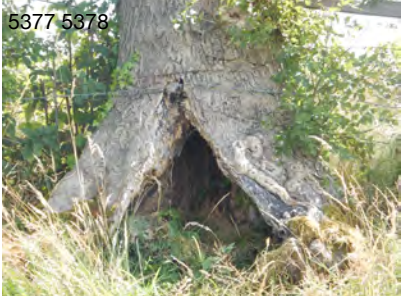
5377 5378 Cavity at the base of main stem, 50cm triangular entrance into main stem cavity. More than 3m upward travel.	Moderate.	Potential for summer or winter roost. Little clear drop distance when exiting or entering, otherwise would have high potential.	Yes

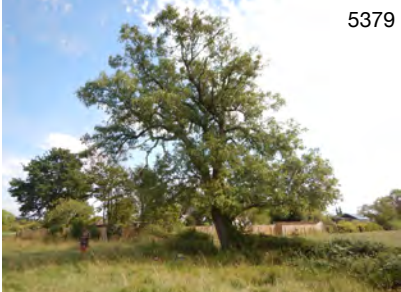
5379 Mature ash with small amount of ivy on lower half of tree. Tear out on east side of tree.	Negligible	No suitable roosting features	No

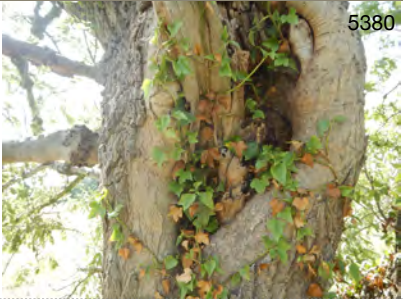
5380 Tear out 60x40 into open cavity exposed heartwood open to the elements not suitable roosting feature.	Negligible	No suitable for bats	NO
T50	Sycamore	8	40

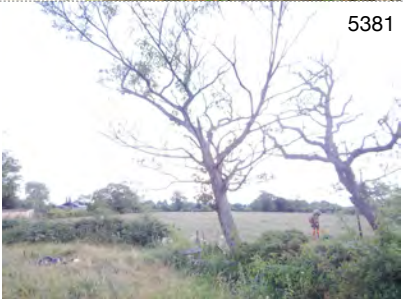
5381 Sycamore on field boundary hedgerow, deadwood in the crown, knotholes on main stem and branches.	Negligible	No suitable features present.	No
T49	Ash	10	80

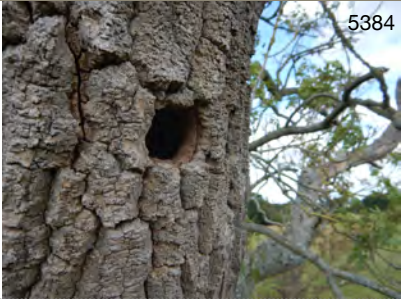
5384 Woodpecker hole with split bark to right. 5cm diameter into hollow vertical limb, 20cm diameter cavity, 50cm upward, 50cm downward. Likely wet in poor weather. Moderate.	Moderate	Moderate potential, as wood above is rotten, and may let water through in the winter.	Yes
T14	Alder	8	40

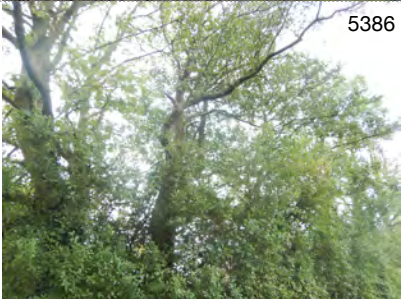
5386 Alder in hedgerow adjacent Bee Lane. Light ivy cover from base to 3m, woodpecker test holes, and deadwood in crown.	Negligible		
T14.1	PRF1	Base	All

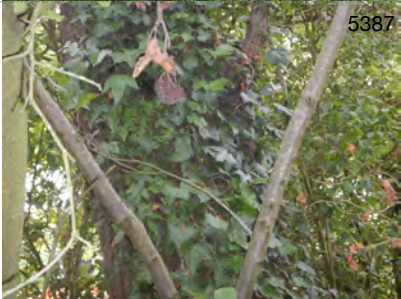
5387 Light ivy cover from base to 3m, not thick enough to form roosting feature, does not hide any cavities.	Negligible		
T14.2	PRF2	4	N

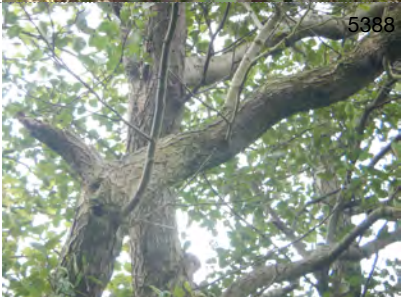
5388 Woodpecker test holes in limbs. 2cm diameter entrance with no suitable cavities.	Negligible

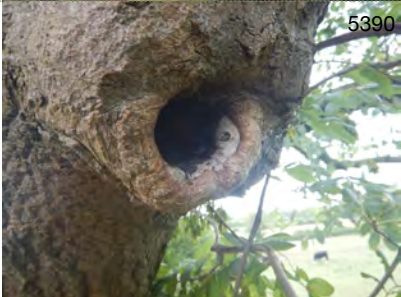
5390 Knothole on underside of diagonal limb. 7cm diameter entrance into tapering upward cavity, opening into 15cm diameter round cavity. Wet inside, slug filled.	Low	Will develop into more suitable cavity in the future.	No
T48.2	PRF2	3	SE

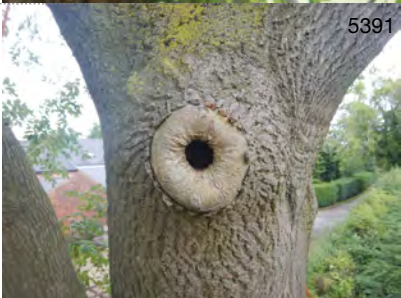
5391 Knothole on main stem, 7cm diameter entrance into 7cm round cavity. Open to the elements, suitable as night roost.	Low	Suitable for single bats.	No
T47	Oak	10	70

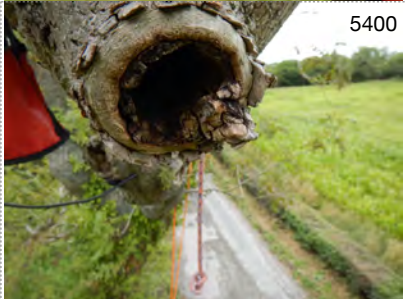
5400 Knot hole in vertical section of limb in the south of the canopy. 5cm diameter entrance into minor wet cavity with 15cm horizontal travel.	Negligible		No
T44.3	PRF3	7.5	S

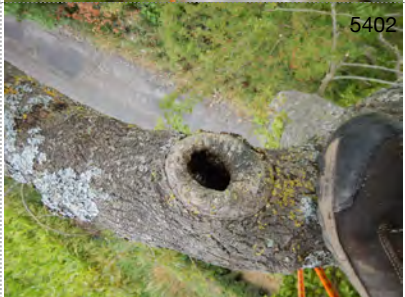
5402 Knot hole on south side of vertical limb. 5cm diameter entrance with no suitable cavity.	Negligible		No

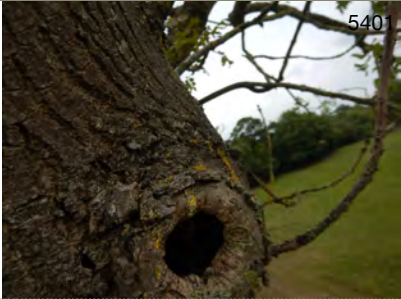
5401 Knot hole in on top of limb in the south of the canopy. 5cm diameter entrance into minor wet cavity with 15cm horizontal travel.	Low	Suitable as night roost.	No
T43	Ash	10	40

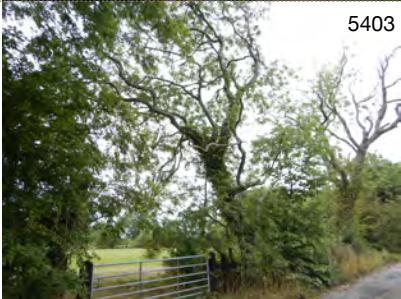
5403 Ash on side of Moss Lane. Dead branches and knot holes in the crown, ivy cover from base to 5m.	Low	Ivy cover does not for. Suitable roosting habitat, or cover other cavities.	No
T43.1	PRF1	1	S

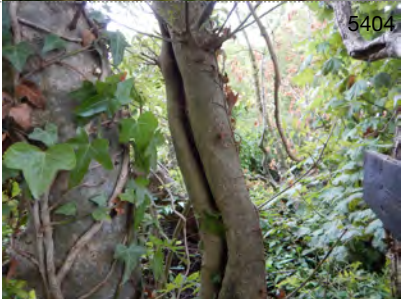
5404 Split in vertical limb at 1m with exposed heartwood and callus rolls. Cavity at top of the split with 2cm diameter entrance and 60cm upward travel in slim dry cavity.	Low	Cluttered, low entrance, otherwise would have higher suitability.	No
T43.2	PRF2	3	S

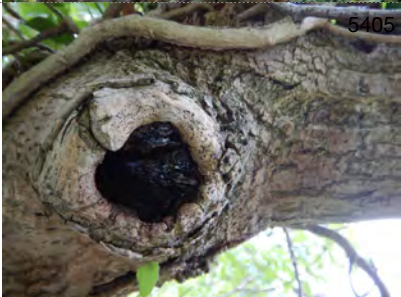
5405 Knot hole on underside of horizontal limb. 5cm diameter entrance with no suitable cavity.	Negligible		No

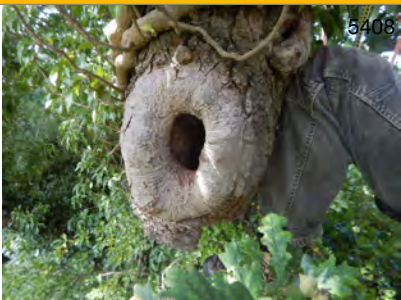
5408 Knothole at 2 metres on the east side. Entrance 10 x 5cm entrance, with 20 cm of downward taper cavity. Open to the elements,	Low	Low potential for bats	No
T39	Alder	8	60

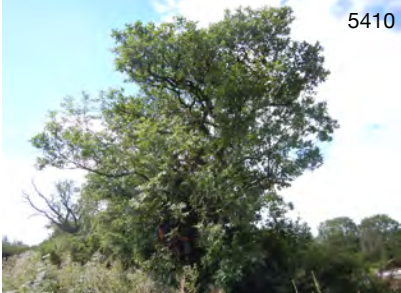
5410 Alder in field boundary hedgerow adjacent ditch. Ivy clad from base deadwood and knotholes in limbs. Ivy does not form a roosting feature or conceal cavities.	Low		No
T39.1	PRF1	3	E

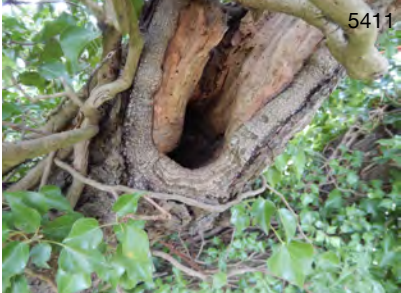
5411 Snapped limb with knothole on east side of tree. 10cm diameter entrance downward travelling, dry cavity 5cm diameter for 50cm. Potential for lower number of bats. Will fill with water in wet weather.	Low		No
T38	Alder	8	40

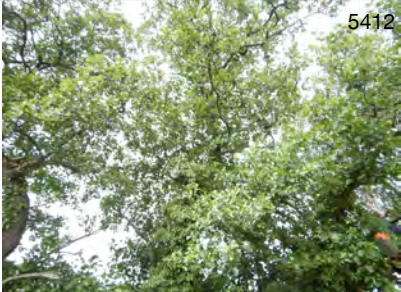
5412 Alder in field boundary hedgerow with snapped limbs in crown, and ivy from base. Ivy does not form a roosting feature, or cover cavities. No suitable roosting features found.	Negligible.		No

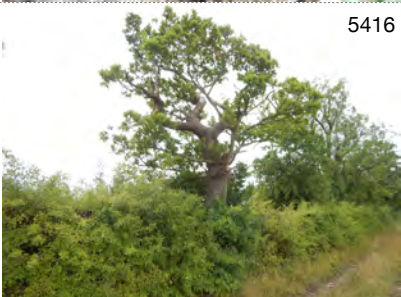
5416	Oak in field boundary hedgerow. Missing bark, exposed heartwood, and knotholes on main stem and limbs.	Low

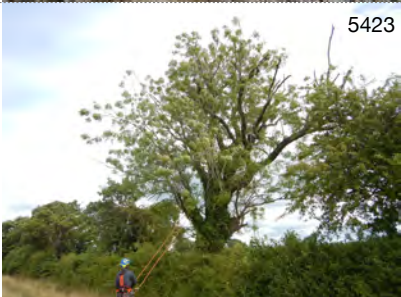
Ash tree in field boundary hedgerow, ivy cover from base to 6m, dead limbs, and knot holes in branches. Ivy does not provide enough cover to form a roosting feature, and no hidden cavities were found.	Low		No

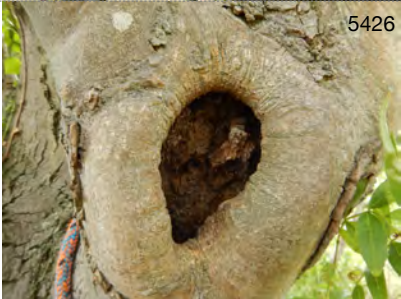
5426	Tear out with upward facing cavity. 10cm diameter entrance with 10cm downward travel, nesting materials inside. Open to the elements.	Low		No
T34	Ash	16	70

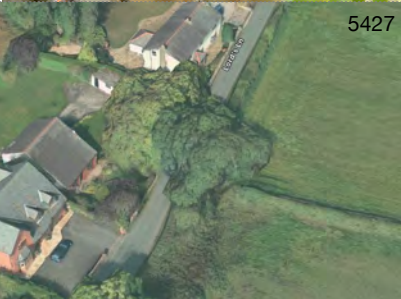
5427	Ash tree adjacent Lords Lane. The tree is adjacent f Asholm. Ivy covered from base to 7m, knot holes and tear outs throughout the tree.	Low	Low potential for roosting bats	No
T34.1	PRF1	3	W

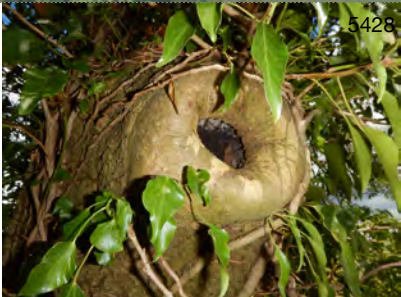
5428	Knot hole on the west side, 10cm entrance with 5cm of upwards travel. Dry cavity partially covered by ivy.	Low	Low potential for a night roost	No

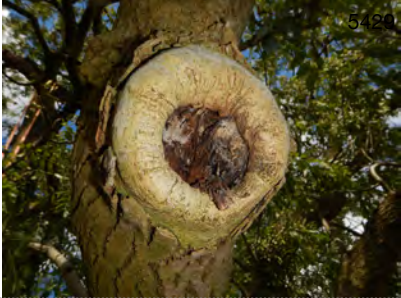
5420 Knot hole, south facing with 7cm entrance no suitable cavity behind.	Negligible		No
T34.3	PRF3	10	E

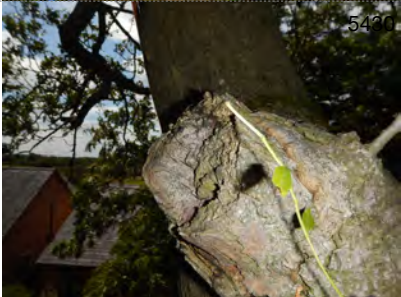
5420 Snapped branch on the east side with no cavity.	Negligible		No
T34.4	PRF4	5.5	N

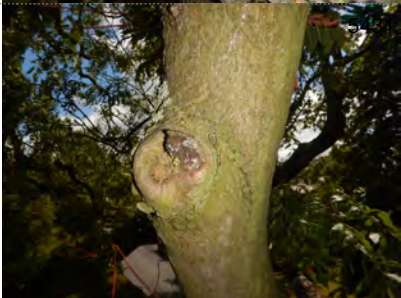
Knot hole on the north side of the tree, 5cm diameter with no cavity behind.	Negligible		No
T34.5	PRF5	7	E

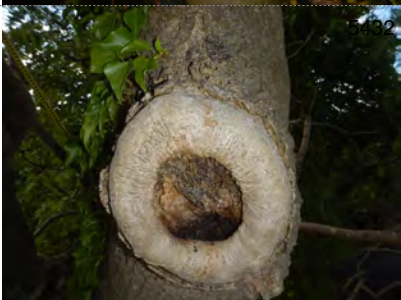
5420 Tear out on the east side, 12cm entrance with 5cm horizontal travel no cavity.	Negligible		No

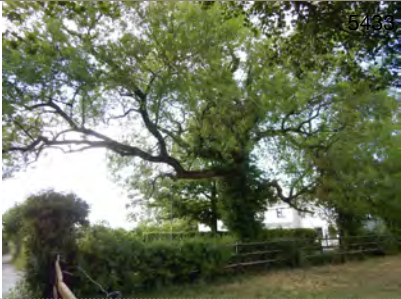
5493	Ash on Lords Lane near junction. Not climbed as on private land.	High	Not climbed as on private land. Possible to survey at dusk - dawn from road.	Yes
T33.1	PRF1	4	SE

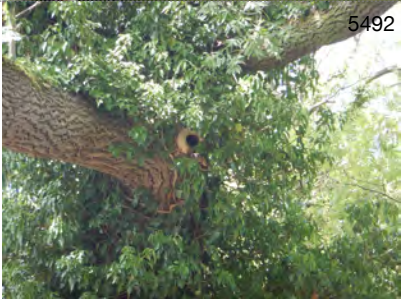
5492	Knot hole on major limb, close to main stem. 10cm diameter, potentially into main stem cavity.	High		Yes
	PRF2	4	W

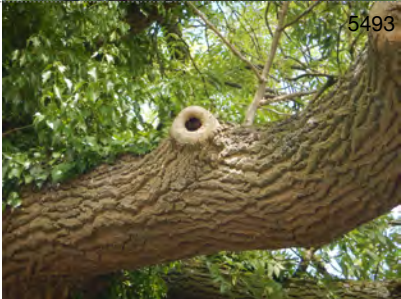
5493	Knot hole on side of horizontal limb, 10cm diameter smooth cavity inside.	High		Yes
	PRF3	6	W

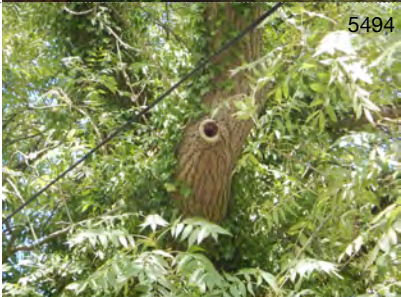
5494	Knot hole diagonal limb with potential cavity.	Moderate		Yes

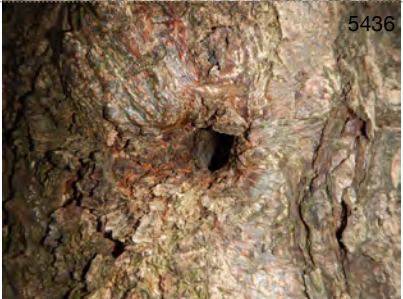
5436	Knot hole on north side of main stem, 3cm diameter entrance into 3cm diameter dry cavity with 10cm upward travel. Suitable as night roost for single or low number of bats.	Low		No
T32.3	PRF3	3	NW

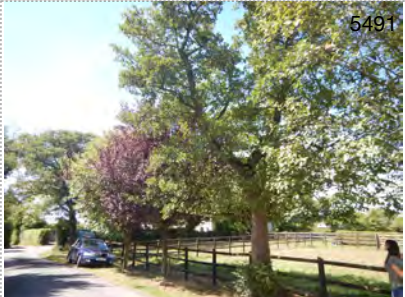
A photograph of an Alder tree on a roadside. The tree is green and has a thick trunk. A car is parked on the road to the left, and a person is visible in the background to the right. The number 5491 is written in the top right corner of the image.	Alder on roadside. Minor deadwood and knotholes on main stem and limbs. No suitable features.	Negligible		
T30	Ash	12	60

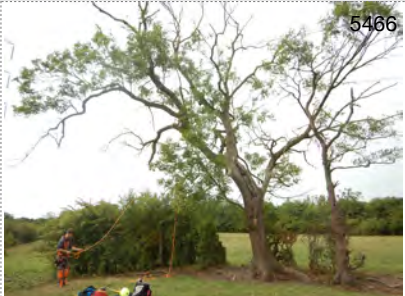
A photograph of an Ash tree in a field hedgerow. The tree is large and has a thick trunk. There is dead wood in the crown and a knot hole in the main stem. A person is visible in the background to the left. The number 5466 is written in the top right corner of the image.	Ash in field hedgerow w. Dead wood in crown and knot hole in main stem.	Negligible		No

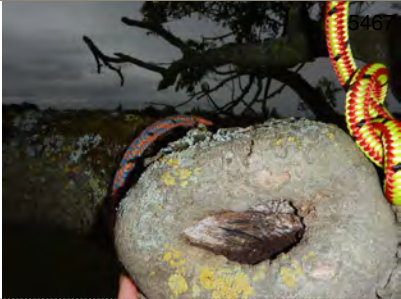
5467 10cm diameter knot hole. Horizontal travel for 5cm. No suitable cavity. Gooney inside.	Negligible		No
T30.2	PRF2	6.8	E

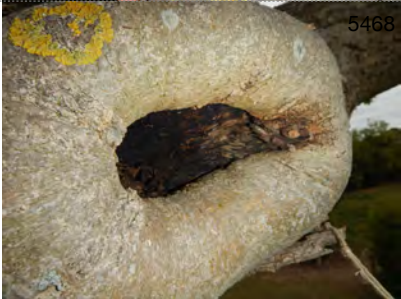
5468 Tear out 10cm by 5cm entrance. Horizontal travel for 10cm into heart wood. Wet inside.	Negligible		NO
T30.3	PRF3	3	E

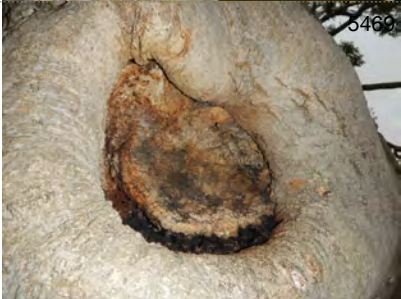
5469 Large knot hole on east side of main stem 20 x 15cm, 20cm horizontal travel, open cavity. No suitable cavities.	Negligible		No
T30.4	PRF4	3	N

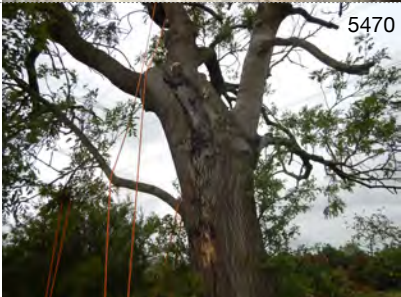
5470 Tear out in main stem on north side with exposed. Heartwood and callus rolls on sides. No suitable cavity.	Negligible		No

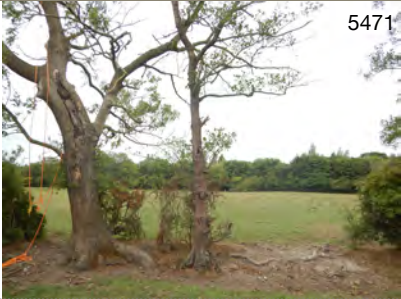
5471 Alder in field hedgerow,	Low		No
T29.1	PRF1	2	E

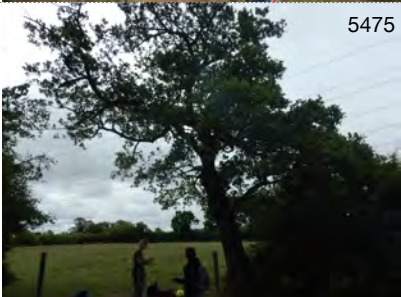
5475 Alder at end of hedgerow. Large cavity at 2m. Series of knot holes from 3 - 7 meters, all checked.	High		Yes

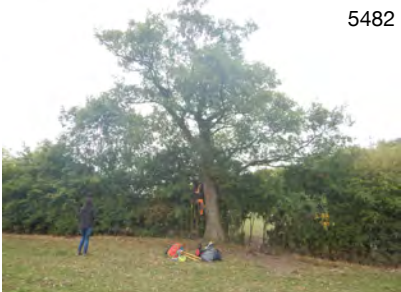
5482 Alder in hedgerow. Light ivy cover. Cavity on east side on main stem.	High		Yes
T24.1	PRF1	2	E

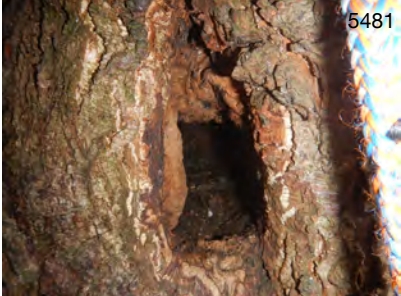
5481 Rot hole with 10 x 5cm entrance into 20cm diameter dry smooth main stem cavity. Old bird nesting material and feathers at base. More than a meter upwards travel. Enclosed above.	High	Slightly cluttered entrance.	Yes
T23	Oak	16	70

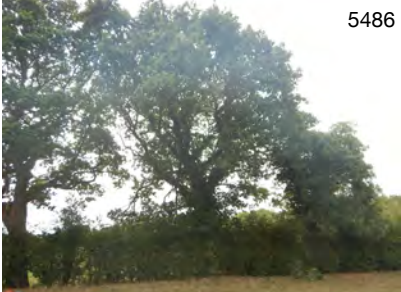
5486 Oak within hedgerow with ivy cover and dead wood in crown. Large (unused) birds nest in crown, possibly buzzard. Tear out on south side of tree, hanging deadwood in tree.	Low		No

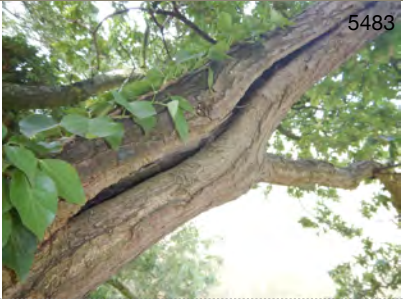
5483 Split on horizontal limb, to N of tree. Callousing around edges. Open on both sides of limb, max 3cm wide, 50cm long. No upward travel. Could possibly be used as a night roost.	Low		No
T23.1	PRF2	5	N

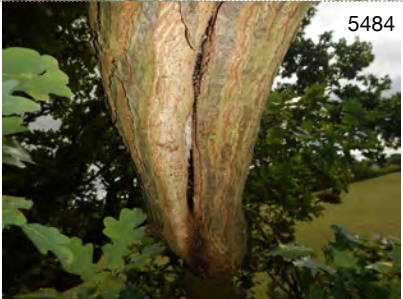
5484 Split in horizontal branch. 40cm long, entrance gap max 1cm wide, cavity too small for bats.	Negligible		No
T22	Oak	14	70

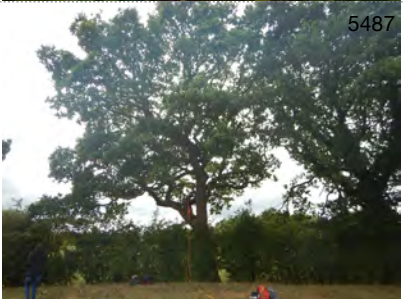
5487 Oak in hedgerow. Large split in a branch union in southeast side of horizontal limb.	Negligible		No
T22.1	PRF1	4	SE

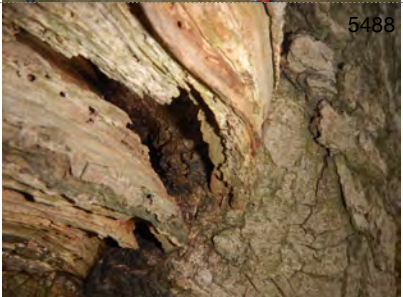
5488 Rotting branch at 4m on southeast side. Dead limb still in place, 10cm horizontal slug filled cavity behind.	Negligible		No

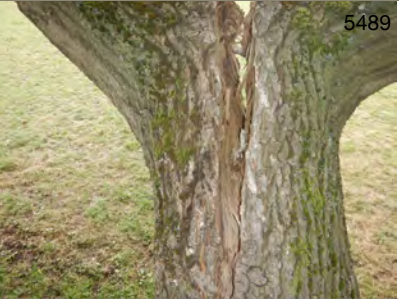
5489 Horizontal limb, Split in branch union, exposed. cavity open above and below. 10cm wide. Split tapers down towards main stem. Exposed to the elements.	Negligible		No
T21	Oak	10	70

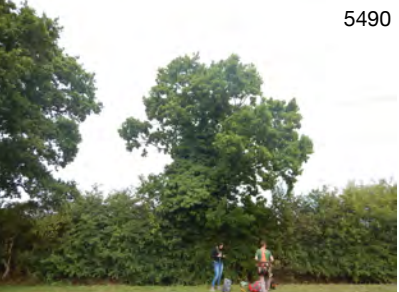
5490 Oak in hedgerow with ivy cover from base, broad stemmed lower down with minor cavity behind. Thinning as it rises into the crown. Deadwood in crown. No cavities or suitable roosting features found.	Negligible	Ivy does not form suitable roosting feature, no suitable cavities found. Cluttered.	No
T20	Ash	12	80

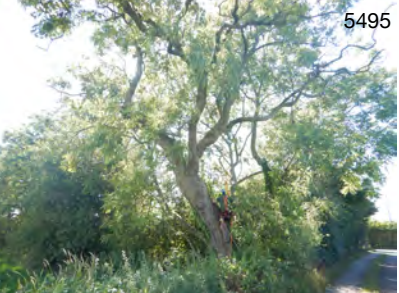
5495 Ash in hedgerow next to (unused) public footpath. Knot hole to east, rotting and open behind. To the south the tree opens up and is exposed.	High	Climbed to 3m as unsafe beyond that. Most of heartwood missing on south side of the tree, open, but has cavities which can't be checked.	Yes

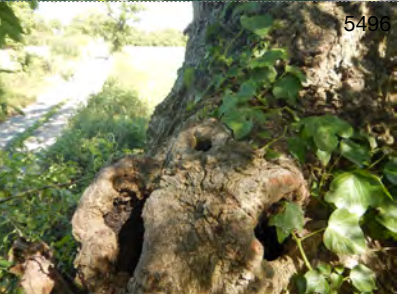
5496 Tear out on northwest of tree. 50cm diameter cavity travels up and down. Tree completely hollow. Cluster of entrances into main stem cavity.	High		Yes

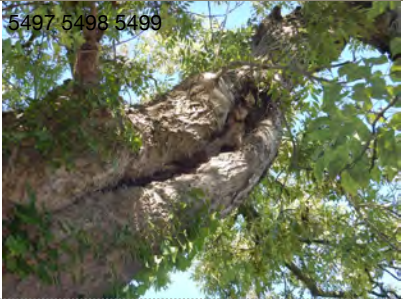
Torn out limb on underside of main stem, hollow, with callus rolls, and the potential for smaller cavities within.	High		Yes
T19	Ash	18	60	5500

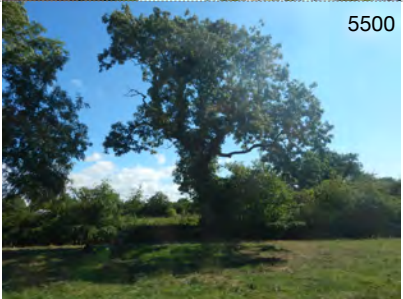
Ash in southwest corner of field boundary hedgerow, ivy clad from 2m into crown, knotholes and deadwood in the crown. Ivy unlikely to provide suitable roosting opportunities. Likely low potential, but given precautionary moderate as unable to climb.	Moderate	Unable to safely climb as next to power line.	Yes
T18	Ash	18	70	5501

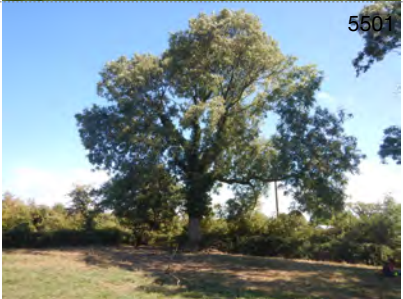
Ash in southeast corner of field boundary hedgerow, ivy clad from 2m into crown, knotholes and deadwood in the crown. Ivy unlikely to provide suitable roosting opportunities. Likely low potential, but given precautionary moderate as unable to climb.	Moderate	Unable to safely climb as next to power line.	Yes

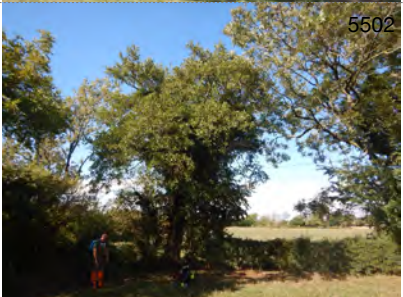
Alder in field hedgerow. Ivy clad from base deadwood and knotholes in crown.	Low		No

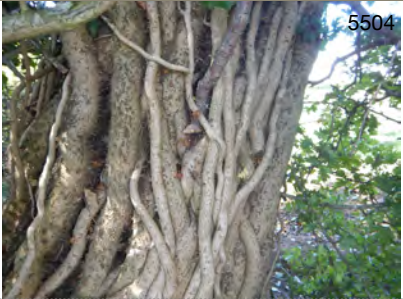
5504 Thick ivy stems forming a mat, with minor gaps below which could be used by single or low numbers of roosting bats.	Low		No
T17.2	PRF2	3	S

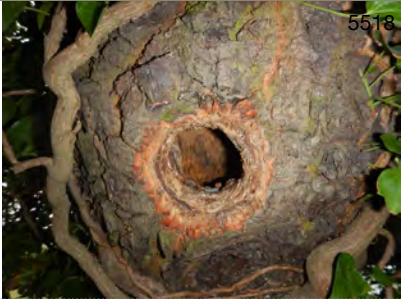
5518 Woodpecker hole on the underside of a main limb, 7cm entrance with 20cm of horizontal travel and 5cm of upwards travel.	Low	Low potential night roost	No
T11.2	PRF2	6	N

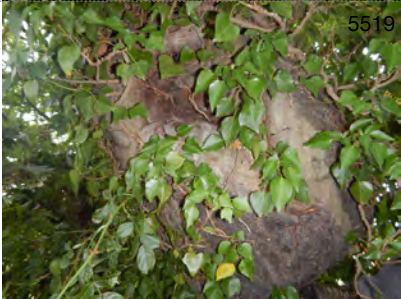
5519 Tear out 30cm entrance with exposed bark and no suitable cavity.	Negligible	Not suitable for bats	No
T9	Ash	7	60

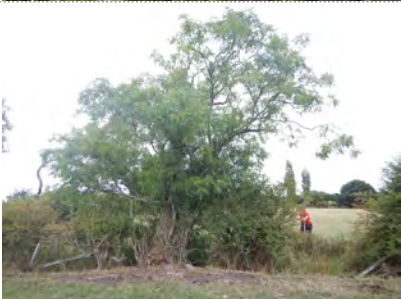
Ash tree in field boundary hedgerow. Ivy cover from base, tear outs and deadwood in the canopy.	High	No safe anchor points in the top of the tree so inspected to 4m. Other potential features above.	Yes
T9.1	PRF1	2	W

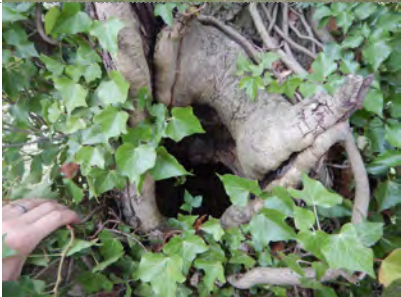
Tear out in main stem at 2m, leading into main stem cavity, more than 1m downward travel, more than 1m upward travel in hollow leader.	High		Yes

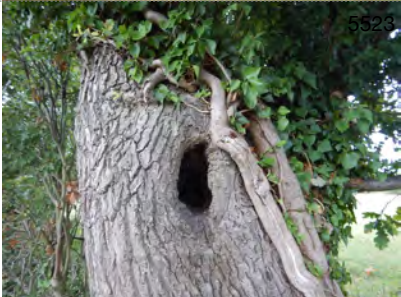
5523 Knot hole on west side of main stem at 1.5m, 15 x 8cm entrance with 30cm horizontal travel in 10cm diameter tapering cavity. Open to the elements.	Low	Cavity is too small and open to be used by large number of bats, or as a day roost.	
T8	Oak	8	60

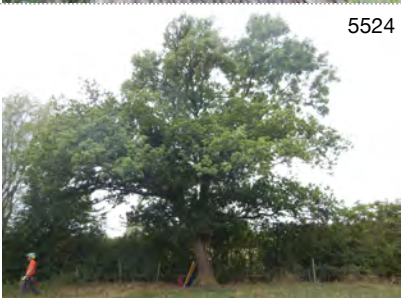
5524 Oak in field hedgerow on northern boundary, adjacent ash. Deadwood and knotholes in the crown, split on east side of main stem from base to 3m.	High		Yes
T8.1	PRF1	<3	E

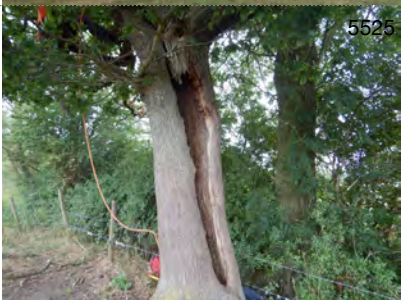
5525 Split in main stem from base to 3m, closing at the top, leading into series of cavities with more than 1m of upward travel. No	High		Yes

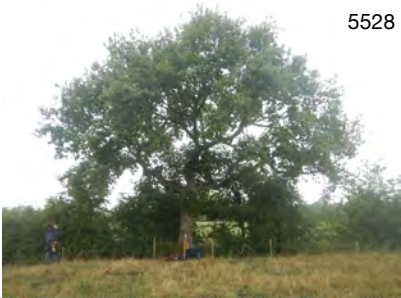
5528	Oak in field hedgerow deadwood and knotholes in the crown.	Low		No
T7.1	PRF1	3	S

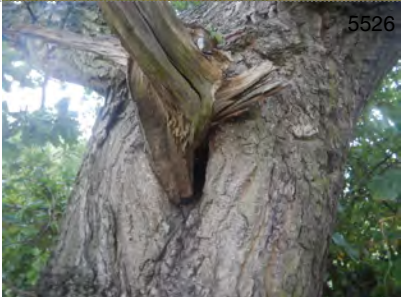
5526	Snapped limb with rot hole at base. Minor cavity at base of dead limb, 10cm horizontal travel. Suitable as night roost.	Low		No
T7.2	PRF2	3.5	W

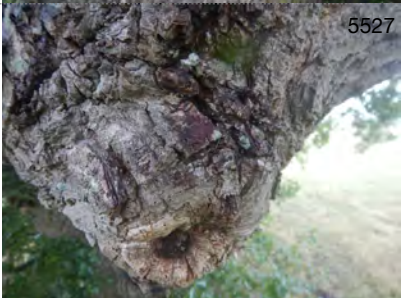
5527	Knot hole 15mm entrance with no 10cm cavity	Low		No
T6	Ash	14	70

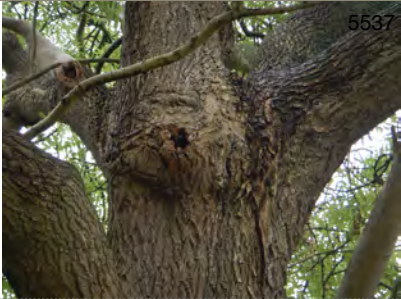
5537	Main stem cavity entrance on the north and south side. Entrance on south side 10cm by 5cm entrance on north side 30cm by 15 cm with > 1 meter upwards travel. Dry cavity	High	High potential for stunner roost	Yes
T6.2	PRF2	5	W

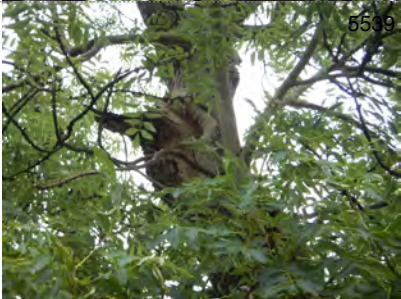
5539	Tear out, from limb on se side of tree, not inspected	Mod	Not inspected due to nesting birds	Yes
T5	Ash

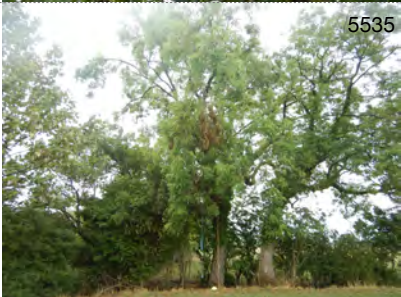
5535	Ash in field hedgerow, mature with deadwood in the canopy and crown, series of knot and rot holes .	High	High potential for roosting bats	Yes

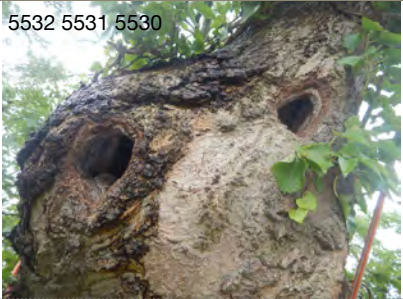
Cavity in main stem with two entrances, 10 x 10cm entrance with 30cm diameter cavity, upwards travel of > 1 meter.	High	High potential for summer roost	Yes
T5.2	PRF2	5	Nw	5534

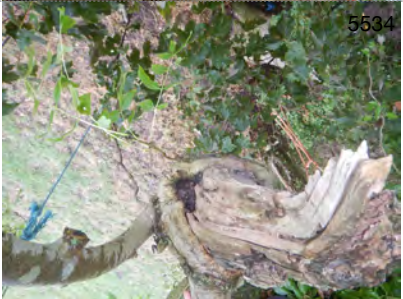
Snapped off limb 10cm callus roll but no cavity	Negligible	Not suitable for bats	No
T4	Oak			5542

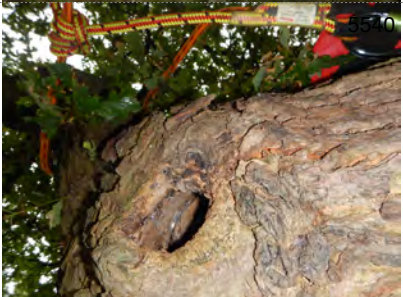
Oak in field boundary hedgerow.	Moderate		Yes
T4.1	PRF1	3	N	5540

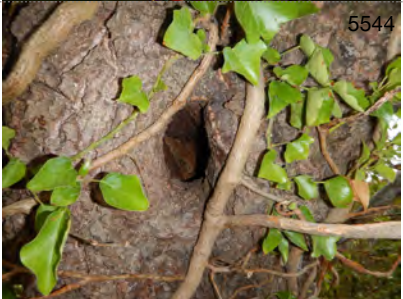
5543	Alder in field boundary light ivy clad from base into crown knot hole on east side	Mod		No
T3.1	PRF1	3	E
